**HISTORY AND DEVELOPMENT  
OF THE 567 SERIES GENERAL  
MOTORS LOCOMOTIVE ENGINE**

***Paper by E. W. Kettering  
Chief Engineer  
Electro-Motive Division  
General Motors Corporation***

***Presented before  
American Society of Mechanical Engineers  
Atlantic City, New Jersey  
November 29, 1951***

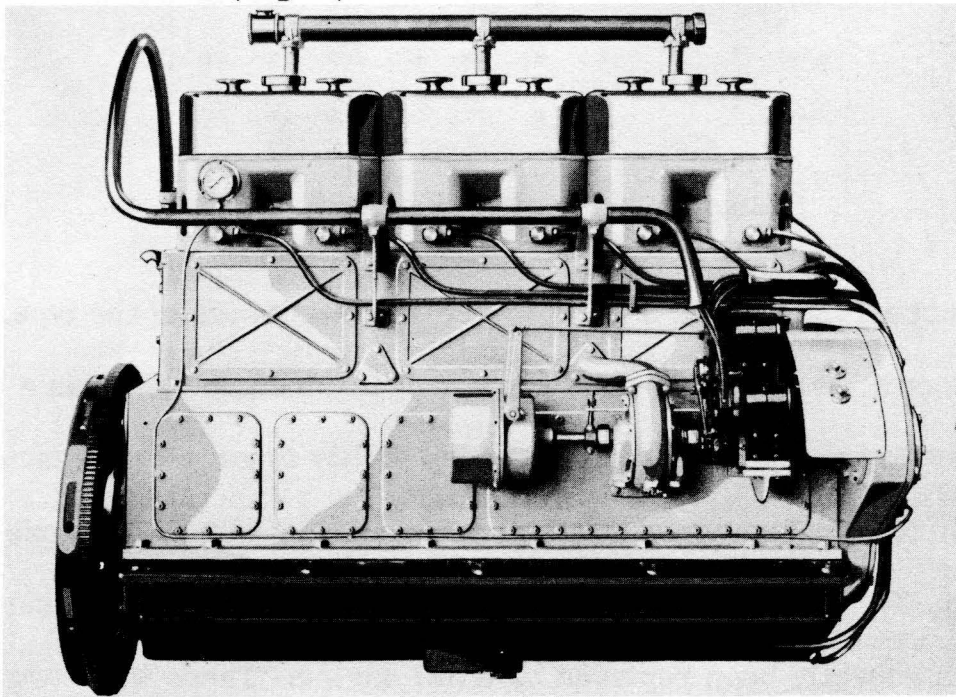
(Fig. 1) Winton Model 106 Gasoline Engine

This engine was designed and built by the Winton Engine Company, Cleveland, Ohio, primarily for marine service but was modified for use in rail cars. This engine generally proved to be successful and many minor improvements were incorporated during the time it was used.

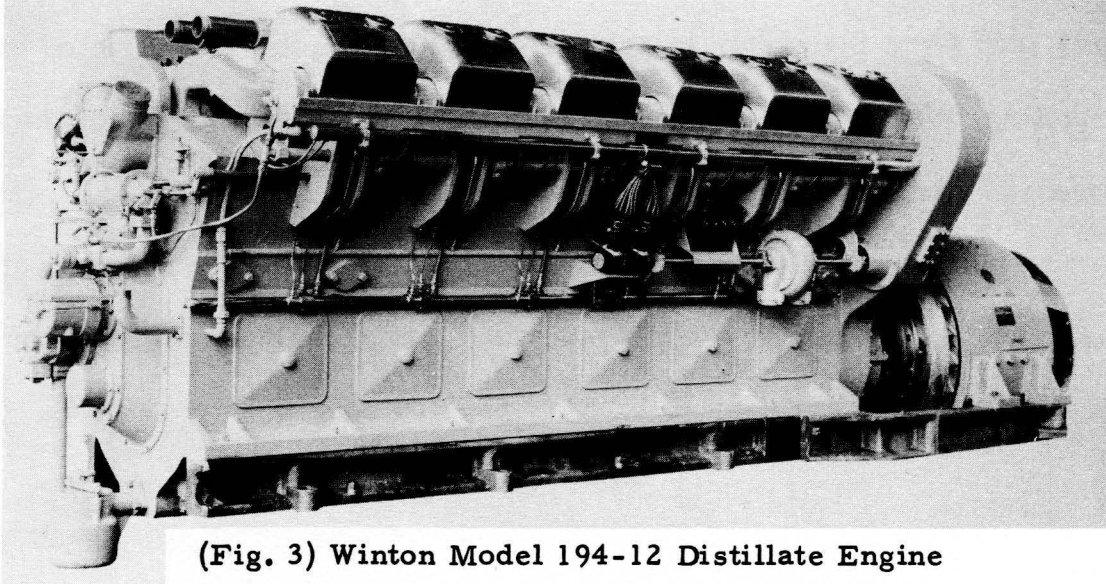
(Fig. 3) Winton Model 194-12 Distillate Engine

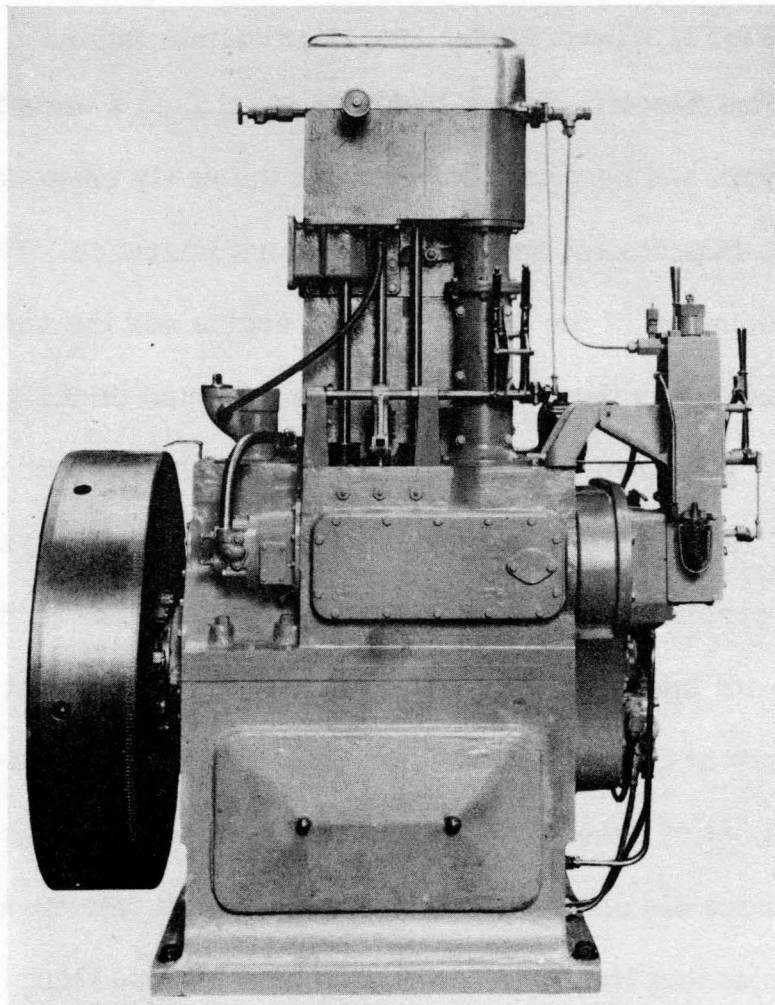
**(Fig. 4) Original GM 2 Cycle 1 Cylinder Test Engine**

One of these test engines was sent to Detroit to be used for investigating the 2 cycle problems and the second was used by Winton to develop the unit injector. Both engines were run 4 cycle to get a base line then General Motors Research converted theirs to 2 cycle. Winton continued to run 4 cycle on injector work. As soon as the engine was run on the 2 cycle principle, many deficiencies were found. The camshaft and valve gear had to be redesigned as they would not operate at the speeds required on a 2 cycle engine. Winton found the cylinder head had to be redesigned to allow more room for the unit type injector. In short, before Winton had a chance to convert their engine to 2 cycle, so many mechanical troubles had developed at Research that it was decided to make a completely new design.

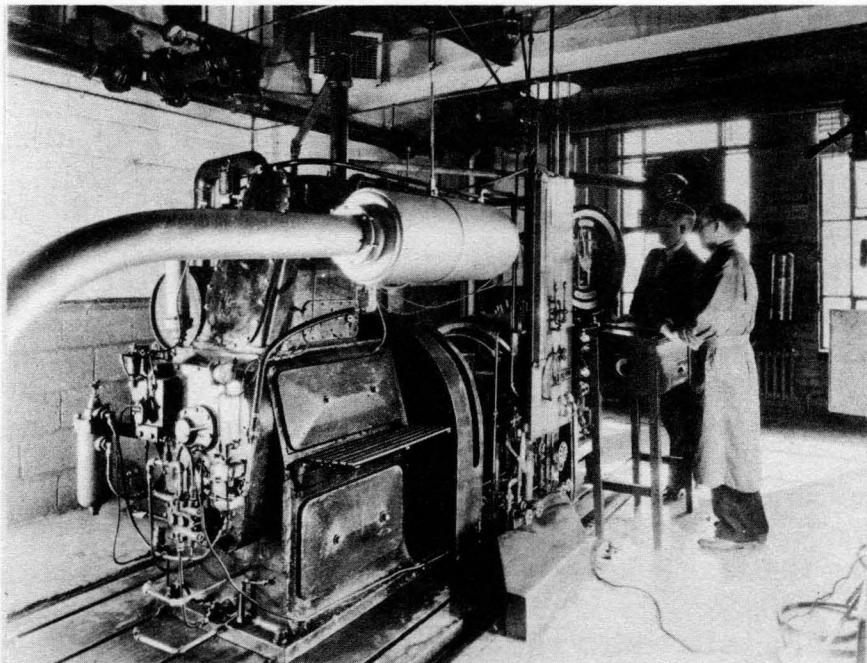
Using the experience at hand, a new single cylinder test engine was designed, incorporating many of the ideas and changes to correct mechanical troubles which had been encountered in the first design. The second design was only 2 cycle so it could be considerably simplified (Fig. 5).

(Fig. 5) GM Research 2 Cycle 8 x 10 Engine

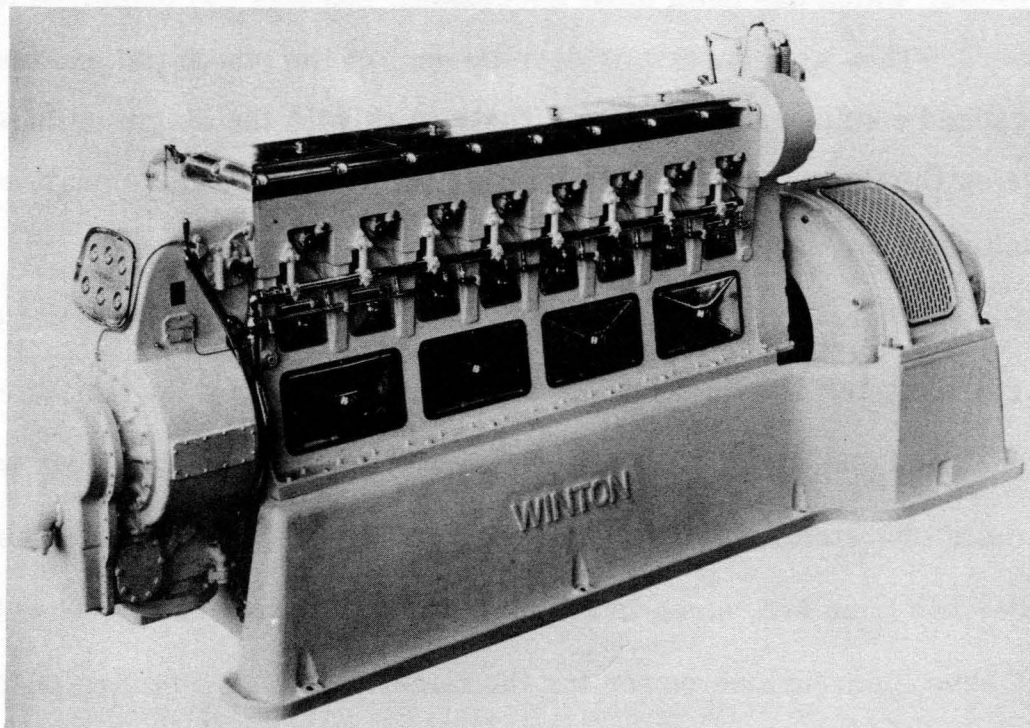
(Fig. 6) Model 8-201 World's Fair Engine

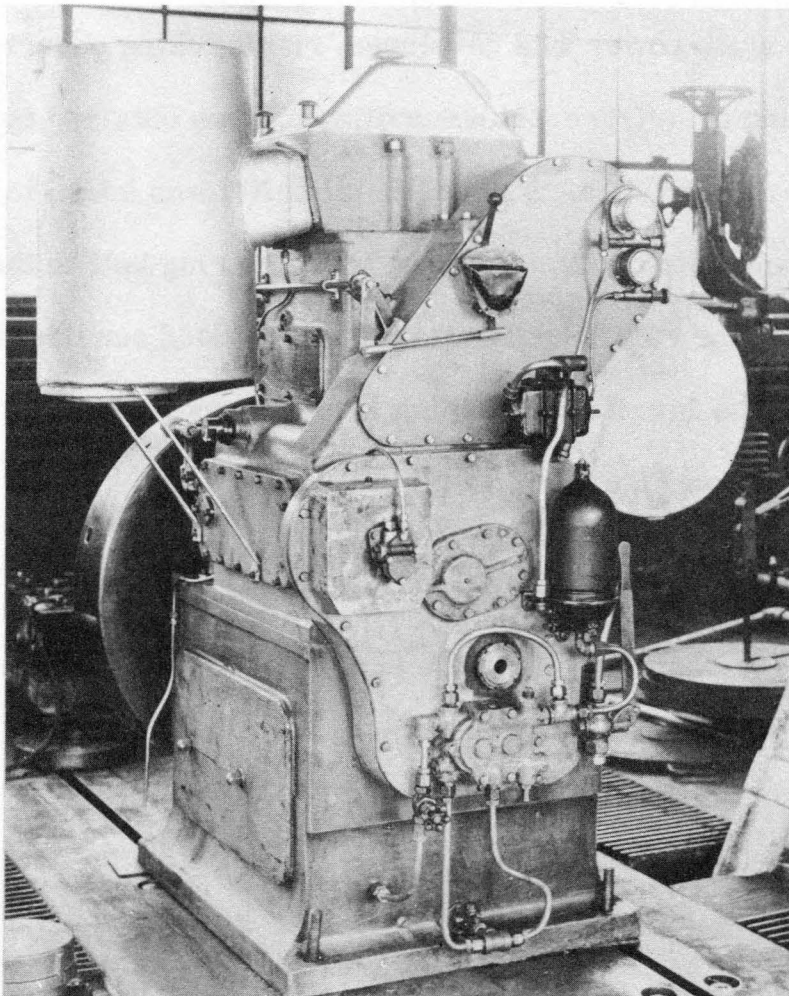
(Fig. 7) 201A Single Cylinder Engine

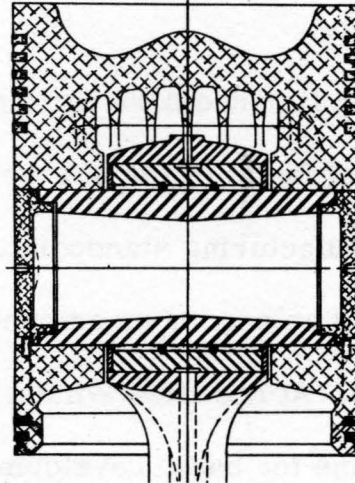
(Fig. 8)

It may be of interest to some of you to go into more detail on how the 1 cylinder engines were used. One of the first parts to show a weakness was the piston. The original piston was a conventionally designed aluminum casting with 6 compression rings above the pin and two oil control rings below (Fig. 8).

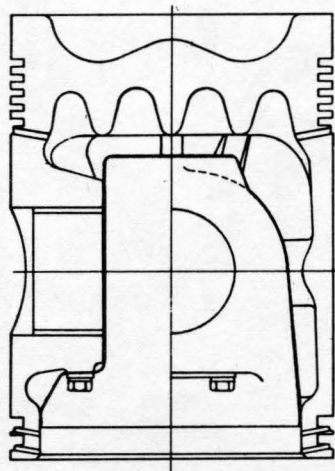
(Fig. 9)

If very much power was developed, ring sticking occurred, causing blow-by and scoring or seizure. More cooling oil was obtained by modifying the connecting rod bearing groove. A sheet metal baffle was added to retain more oil within the piston and help conduct the heat from the ring belt to the skirt. This definitely improved the ring sticking condition but added considerably to the oil control problem. The lower compression ring was converted into an oil ring. This piston is shown on Figure 9.

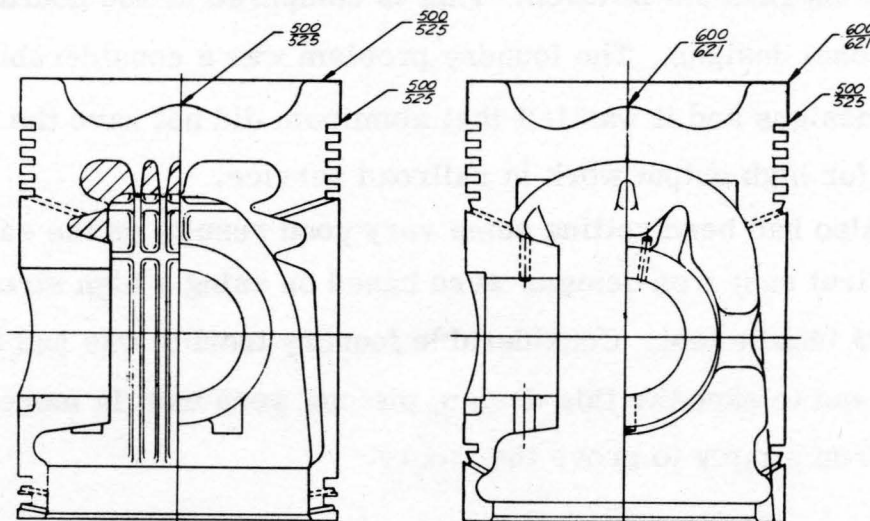
(Fig. 10)

A new and much more elaborate piston development program was started. This was early in 1934 and before the end of the year the five single cylinder engines were working wholly on the piston problem. This project had three basic parts; first, to continue with the development of the conventional design to try to get the best possible performance at 75 HP per cylinder; second, to carry on two new development ideas, one known as the heat dam aluminum design; and third, a completely new design in high strength cast iron. Figure 10 shows two of

the most successful of the conventional aluminum designs tested with the temperatures recorded at the three basic points above the top ring, the top land, and the center. There was later a third modification in which this design was made into a forging, which added to its service life considerably. This is the piston still being used in this engine.

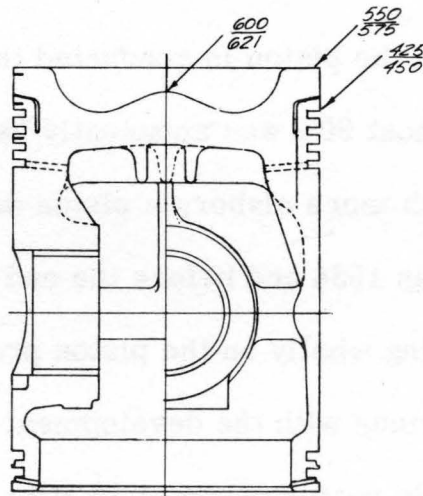
(Fig. 11)

In the heat dam design an attempt was made to cast a thermal barrier behind the top ring to equalize the flow of heat to the ring belt and force the lower rings to do more of this work. Of this general type of piston seven designs were run. Plenty of trouble was encountered. The most successful one was design #3 shown in Figure 11.

This piston was run over 1300 hours at 82-1/2 HP per cylinder with no ring sticking or mechanical failures. This is compared to 100 hours at 82-1/2 HP on the conventional designs. The foundry problem was a considerable headache in many of these designs and it was felt that aluminum did not have the mechanical life necessary for high output work in railroad service.

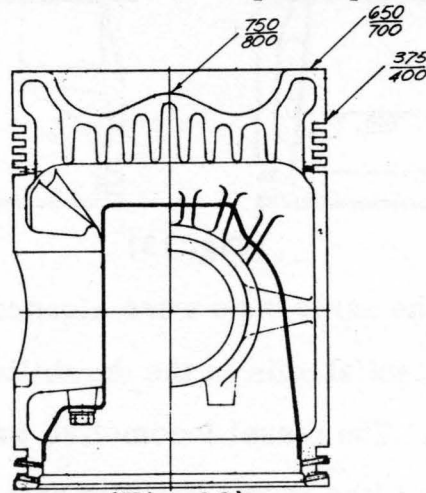
(Fig. 12)

Much to our surprise we found the piston with minor modifications ran very successfully in the lower strength alloys. Figure #12 shows one of the better cast iron designs run in these engines. In fact, some of you might see considerable resemblance between the first 567 one-piece pistons and this one.

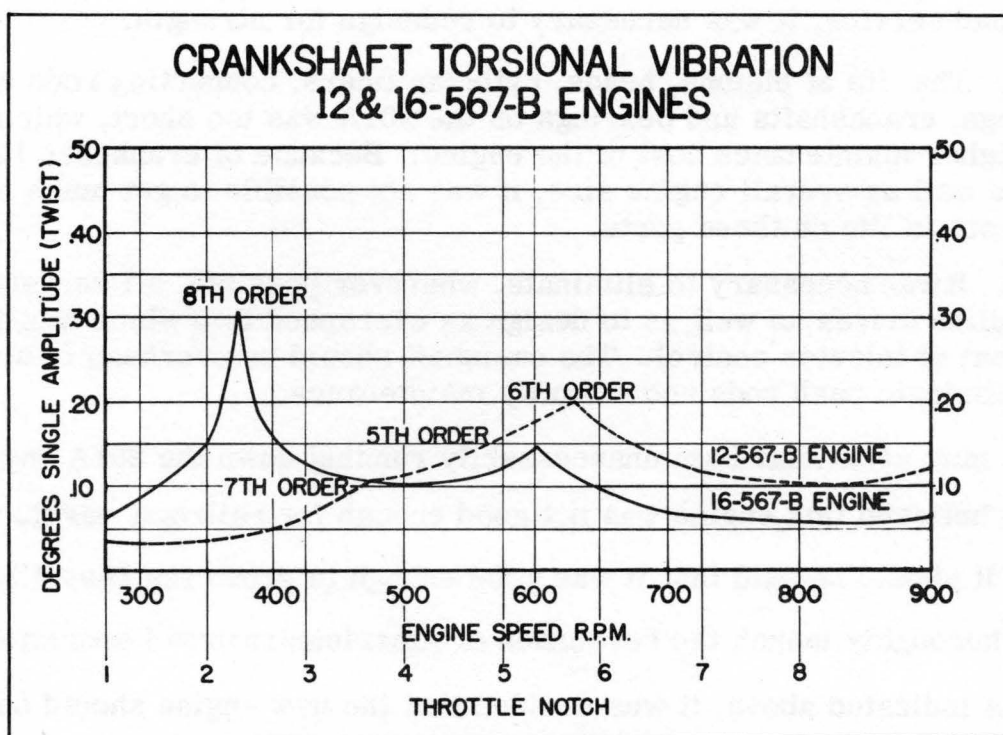
(Fig. 14)

Figure #14 indicates the crankshaft torsional vibration throughout the operating range for a 12 and 16 cylinder engine. The degree of torsional vibration is not sufficient to cause shaft, bearing or gear train difficulties. It can also be noted that the maximum amplitude of torsional vibration does not occur at any governed speed. It is of interest to note that the maximum order of vibration for each engine (number of twists per crankshaft revolution) is the same as the number of crankpins.

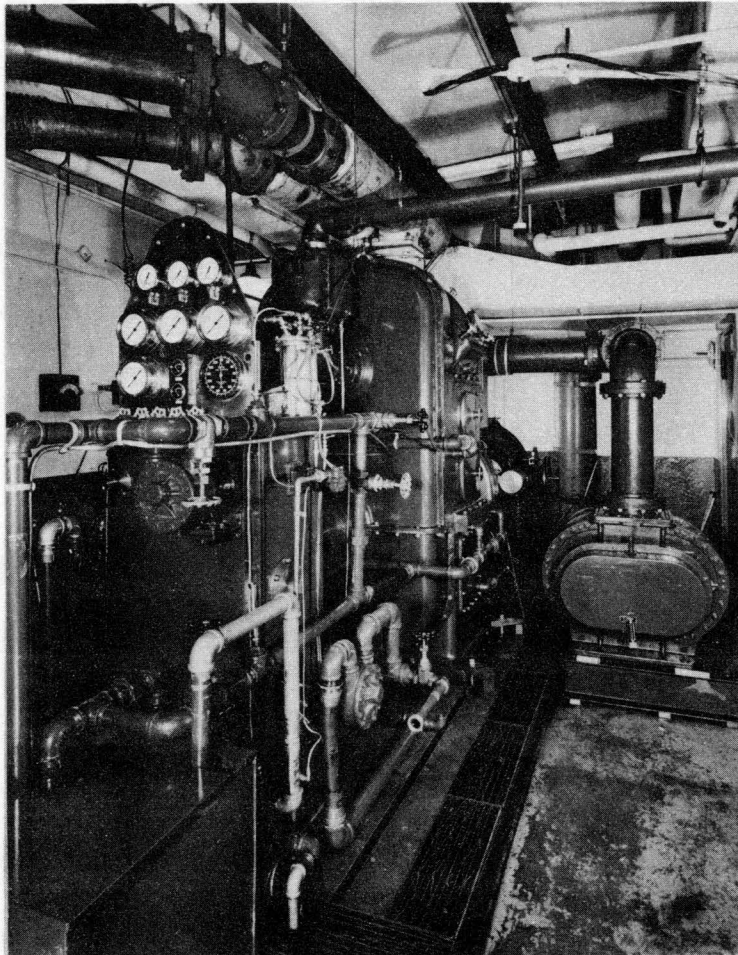
In order to develop power assemblies of the multi-cylinder engine as well as get more background on the combustion characteristics of the engine than it had been possible to work out on the single cylinder General Motors Research engine, we built one 2 cylinder 45° "V" 567 engine (See Fig. 15).

(Fig. 15 ) Original 2-567 Test Engine

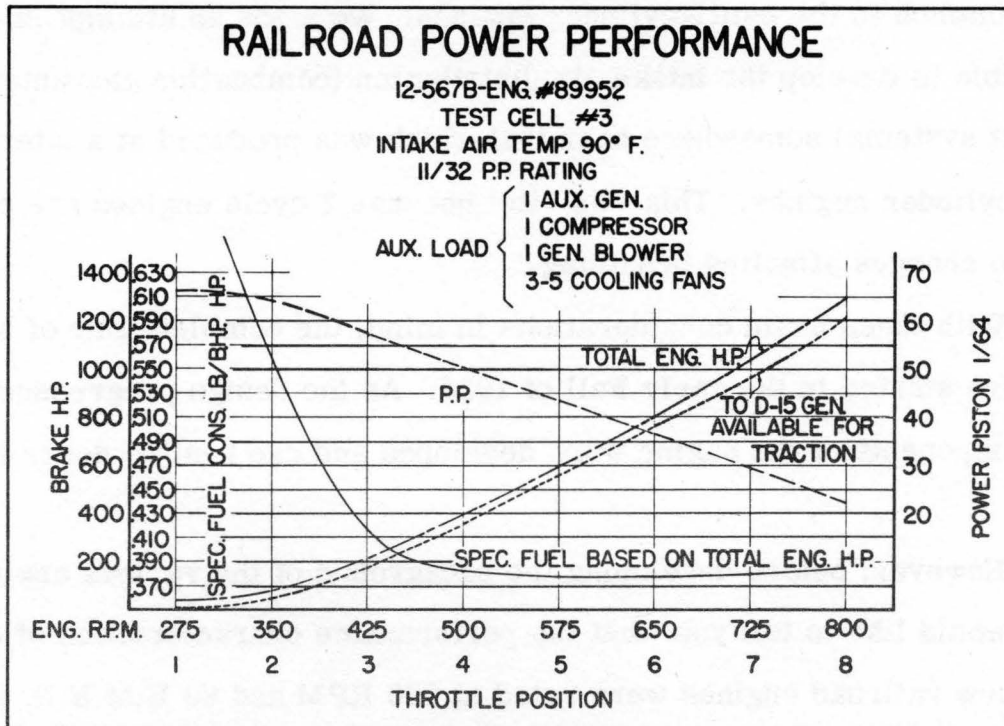
(Fig. 16)

Figure 16 will serve to explain this, indicating total engine horsepower at rated load of 1280 for a guaranteed locomotive horsepower of 1125 and an actual delivered horsepower to the generator of 1210. These data were run at 90° F. ambient.

This graph also indicates additional performance characteristics of our engines. Our road locomotive load control regulates the engine to only eight output positions or throttle notches. At each throttle notch the engine operates at a governing speed and fuel input. This latter control in our language is indicated by power piston gap measurement. This graph indicates the pre-determined characteristics of speed and fuel input. The plotted characteristics of output and specific fuel consumption are results and will vary with engine conditions, atmospheric conditions, altitude and fuel B.T.U. value. A paper entitled "Altitude Performance of Electro-Motive 567 Engines Under Railroad Conditions" by Barth, Lyon and Wallis presented before the S.A.E. on November 2-3, 1950, develops the effects of these variables on engine output.

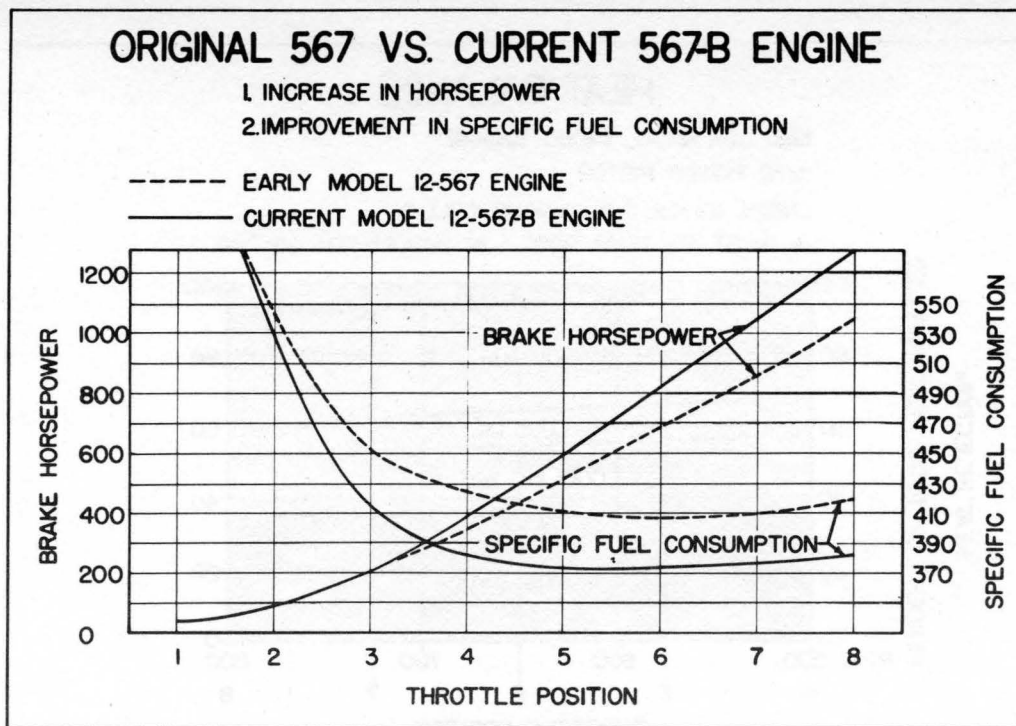
(Fig. 17)

Rated load specific fuel consumption of the engine is .382 pounds per brake horsepower hour. Throughout the upper engine operating range this excellent economy is exhibited. However, this output and economy are a result of engine improvements achieved through the years. Figure 17 compares our original production engines with those manufactured currently. Under rated load conditions output is increased 17% and specific fuel consumption has decreased 9%. The reasons for these improvements will be developed later. It might be well to note here we are making a line of engines not only for Main Line locomotives, but also for Switching service so that we were not only striving for good fuel economy at high power but also good economy at idle and low power conditions for switching service. This has definitely been accomplished. Field results show our switching locomotives to be very low in fuel consumption.

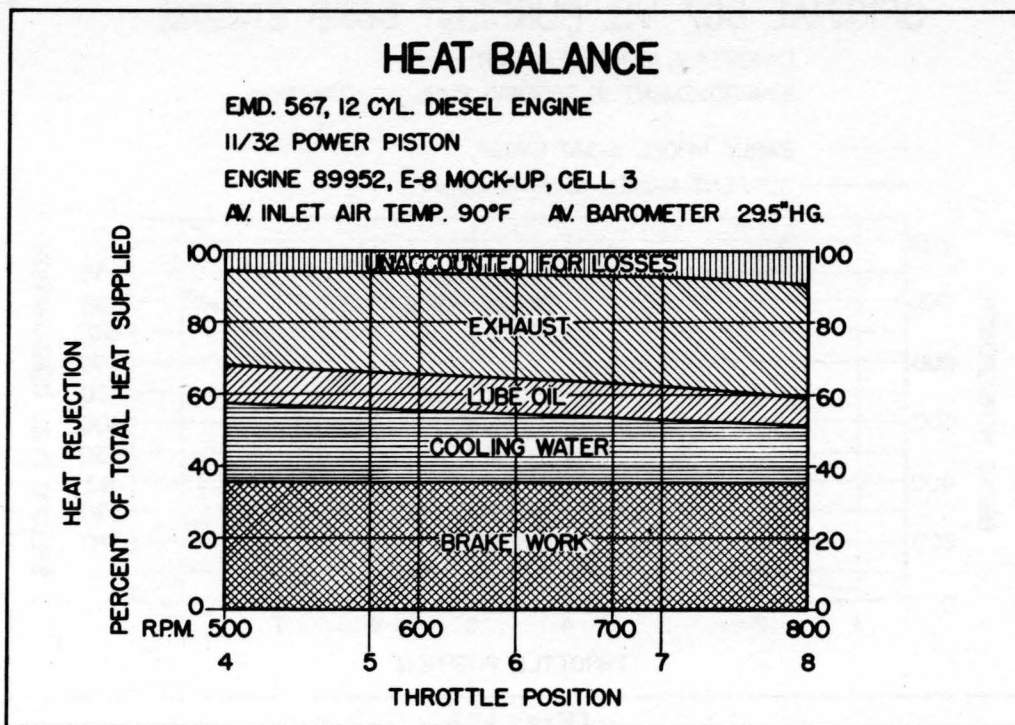
(Fig. 18)

Figure 18 indicates the distribution of energy produced during engine operation as a heat balance. At rated output the brake work utilizes 33-1/2% of the supplied fuel (indicative of thermal efficiency) and normal energy dissipation includes exhaust 31%, cooling water 19% and lubricating oil 7%.

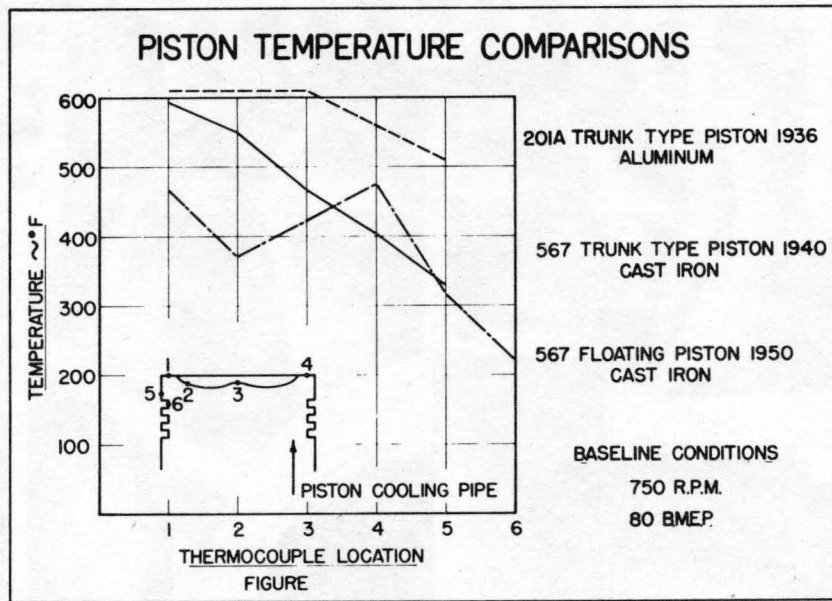
(Fig. 19)

readily duplicated on the 2 cylinder 567 engines. This was approximately 150° lower than the aluminum pistons on the 201A engine (Fig. 19).

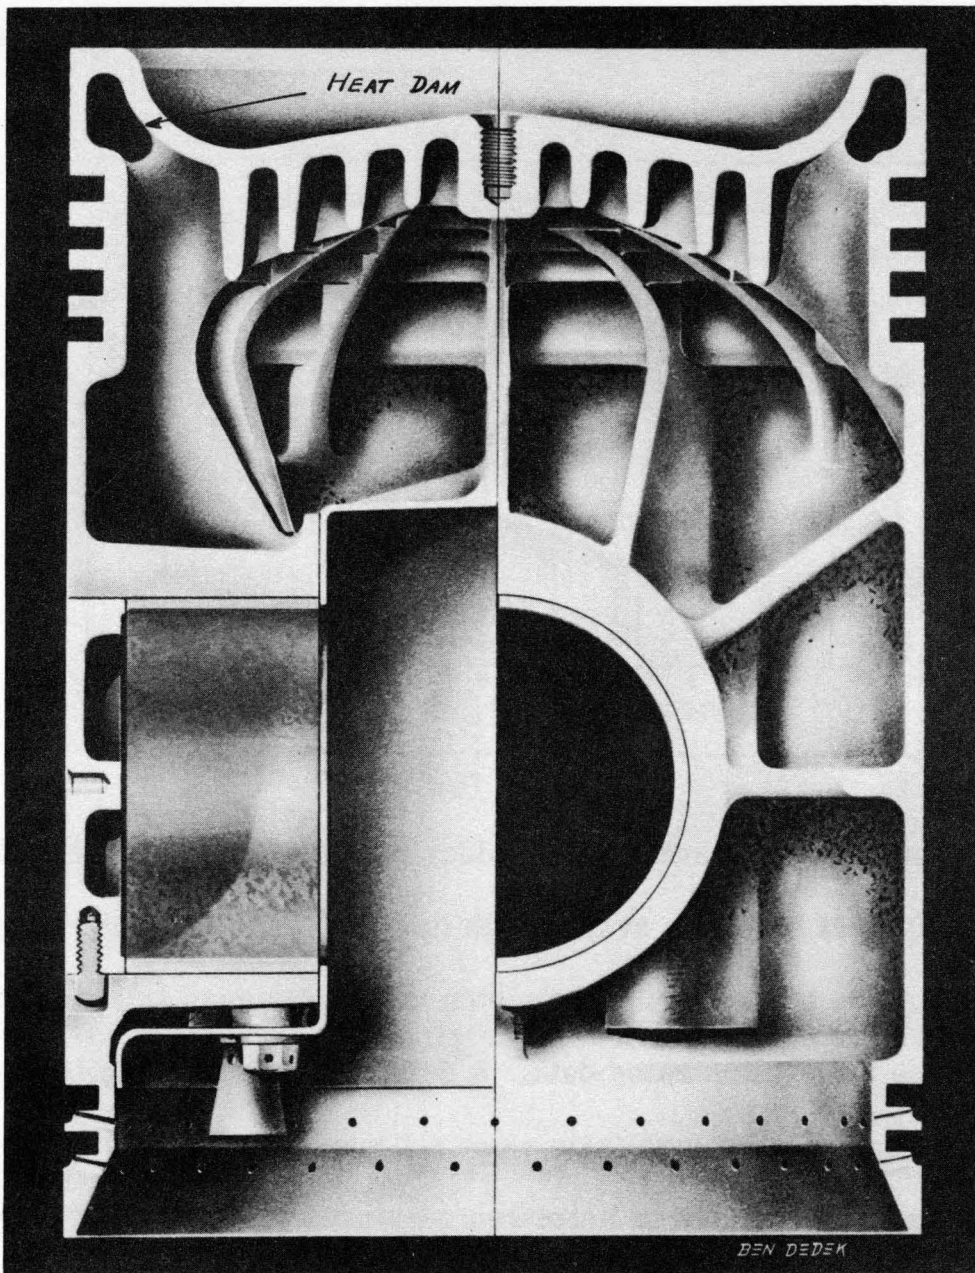
With regard to the actual design of the piston it was known that a heat dam above the top ring was necessary in order to maintain relatively low ring belt temperature. This heat dam as illustrated (Fig. 20) restricted the heat to the ring belt, the crown and rim heat being removed by the cooling oil. It was found to be possible by means of jet cooling, that is, directing oil through an orifice aimed to a hole in the piston baffle, to get an adequate supply of oil to properly cool the piston.

(Fig. 20) First 567 Piston

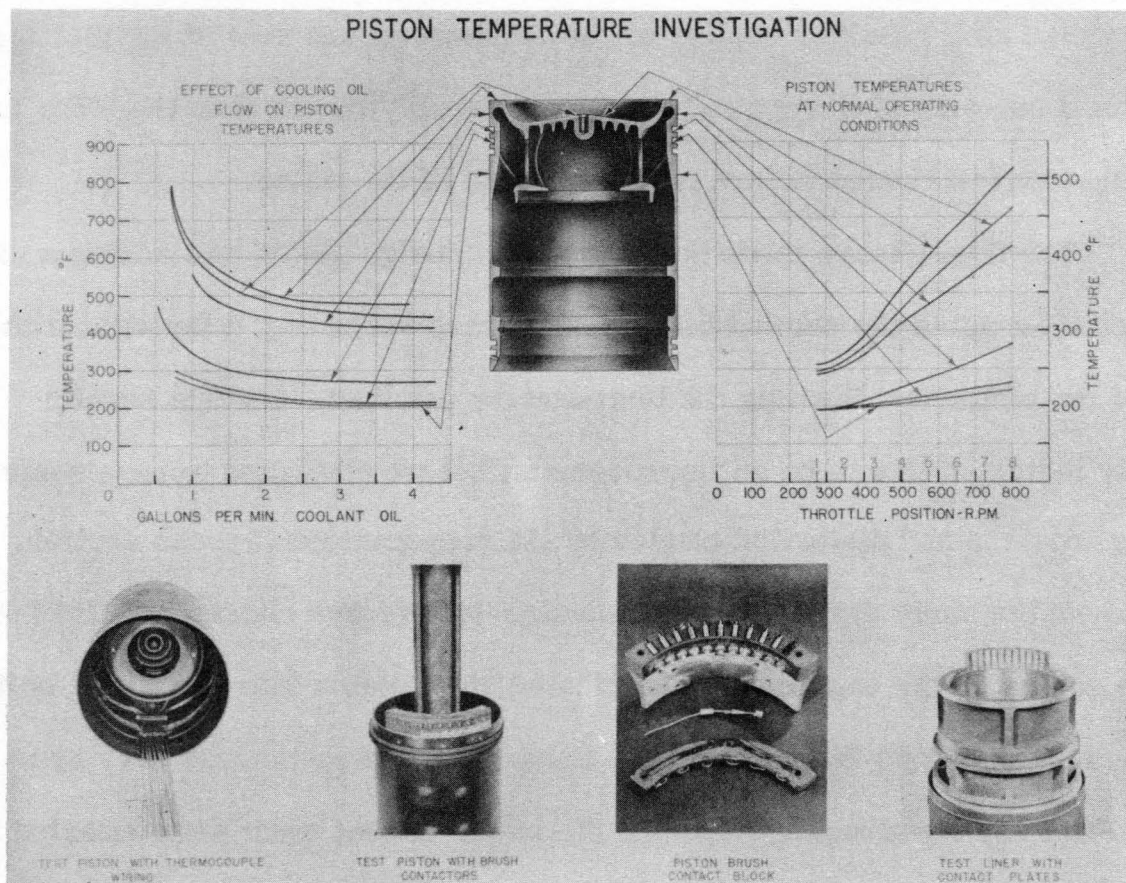
Most of this testing had been done at equivalent full load on the single cylinder engine and there was considerable discussion as to whether the cooling oil should be in proportion to the B.M.E.P. or torque or whether the cooling oil should be in proportion to the speed. It was finally decided, inasmuch as a railroad engine runs on known power curves, that we should make the system as simple as possible with no control valves by connecting the pump directly to the piston cooling jets. This decision proved sound for railroad application, although some trouble has been experienced when high B.M.E.P.s are run at low engine speeds such as resulted from the poor selection of a propeller in one of our tug-boat applications. Figure 21 illustrates the excess of cooling oil shown on the left-hand side of the chart. The curve on the right illustrates actual operating temperature under railroad conditions. The photographs at the bottom of the chart illustrate the intermittent method used in measuring piston temperatures.

As indicated on the previous chart (Fig. 21) considerable thermal stress existed as a result of cooling oil impingement on one side of the piston rim. This caused one side of the crown to run considerably cooler than the other and the thermal stress caused failure on the hot side of the piston.

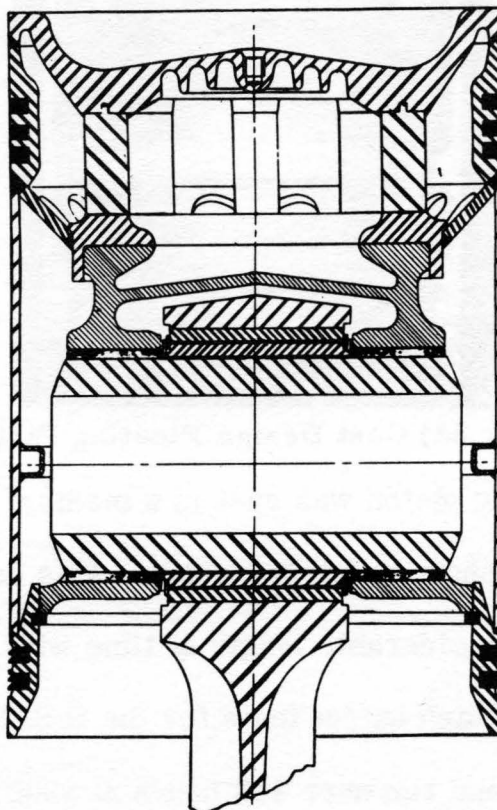
the skirt in any way. The appearance of this piston was excellent and all of the test data indicated it was a very successful design. In an attempt to copy the 184 design we ran into some basic difficulties, the principal one being that it was impossible to bolt the trunnions into a design similar to the 184 because the piston cooling jet location was exactly where the bolt should go. A number of waste baskets were filled with drawings trying to design our way out when one day someone made the very simple suggestion, "Why not make the piston pin bosses part of the baffle and pilot it at the top and bottom and retain it with a snap ring?". Calculations indicated that the snap ring would be considerably stronger than any bolts or capscrews which could be applied. To simplify machining, another suggestion was made that the upper pilot be made round rather than using dowels or other methods of location. This meant the piston was free to rotate about the carrier and could be perfectly symmetrical so that upon expansion it would retain its original round shape.

(Fig. 22) Fabricated Design Original 567 Floating Piston

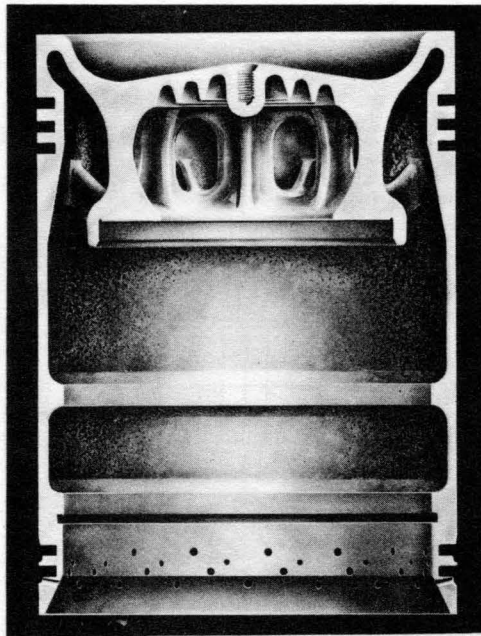
The cast design had struts tying the platform into the ring belt based on the above experience (Fig. 23).

(Fig. 23) Cast Design Floating Piston

The first floating piston was cast in a medium grade cast iron as we wanted the weak points to show up fairly quickly. This design piston was run in a 16 cylinder engine for a considerable length of time with no failures. In fact, when asked to run some special high output tests for the U.S. Navy the engine with these floating pistons was used and run over 400 hours at 2000 B.H.P. and a total of 24

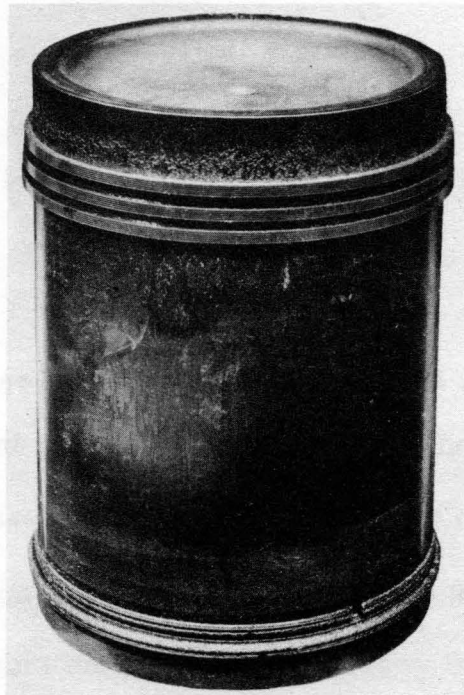
A brief comparison can be drawn as to life of pistons in passenger service. These comparisons must be based on passenger operation as there never were any 201As in any other service than passenger and switcher. The 201A aluminum piston at the very beginning did not run 50,000 miles and the later 201A pistons ran a questionable 100,000 miles in hard service. The average life of the first 567 piston was in the range of 400,000 to 500,000. On one major railroad the average life of the current design two-piece piston is at least one million miles (Fig. 24).

(Fig. 24) Million Mile Piston

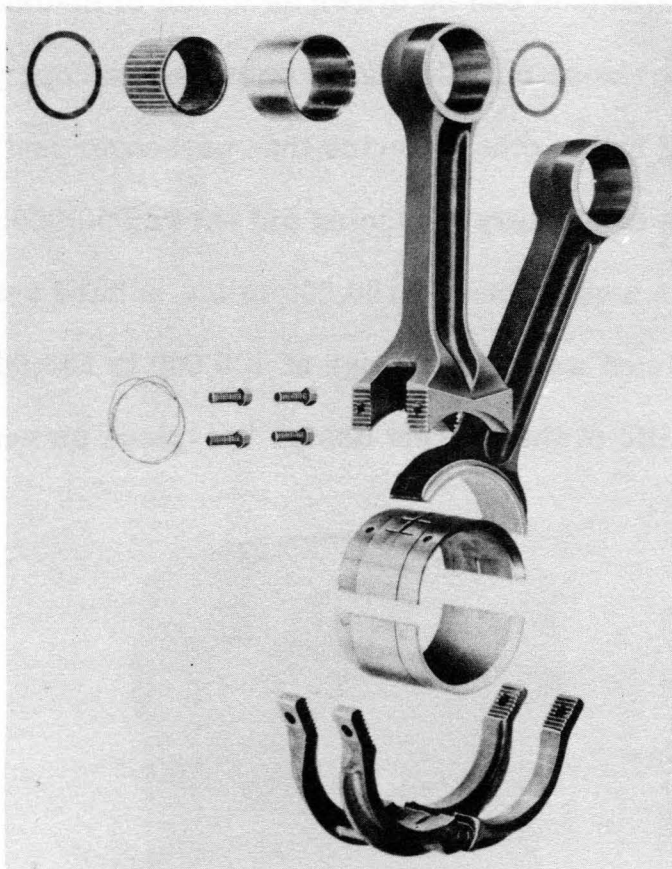
The 567 connecting rod as illustrated in Figure 25 was made of fork and blade design in order that we might make the engine as short as possible, yet with the maximum pin bearing length and make the crankpin as large in diameter as possible. The serrated type basket was used for both of the above reasons, that is, to have the largest connecting rod crankpin bearing possible and still be able to remove the connecting rod through the cylinder bore. Extensive development work on the blade and fork connecting rod and bearing was carried out on the 2 cylinder engine.

(Fig. 25) Fork and Blade Rod Design

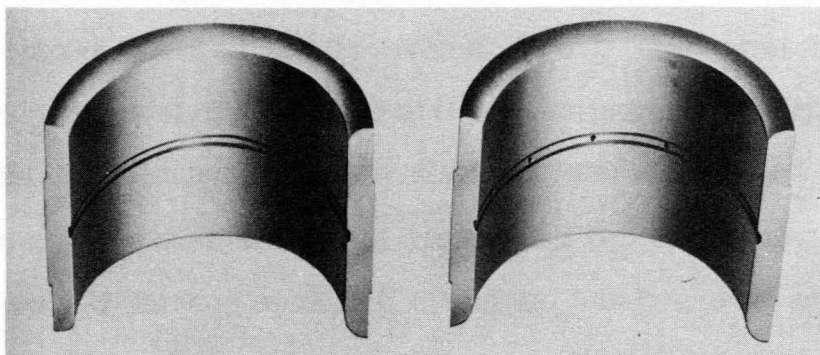
early troubles with this design, namely the copper-lead material was low in fatigue strength and the 360° circumferential groove increased the bearing pressures. The two cylinder engine showed us that a lead-bronze lined bearing on the inside diameter with no groove and only connecting holes through the bearing to lubricate the blade rod surface had eliminated the shelling out of the inside diameter. This change was made and proved to be relatively satisfactory.

(Fig. 26) First 567 Connecting Rod Bearing

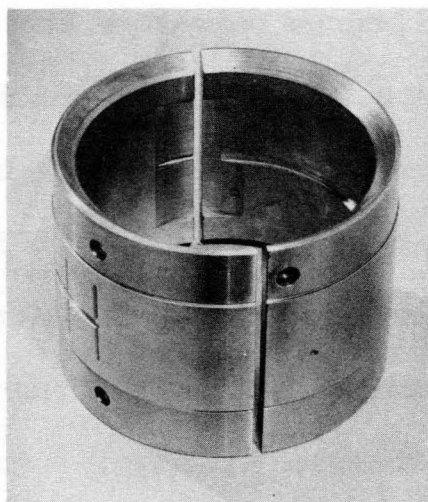
In 1941 a final design change was made (Fig. 27), this being the seventh design in all, in which the oil was fed from the mudpocket at the split line through a tangential hole to a circumferential groove on the outside diameter. To this circumferential groove were connected cross grooves, all grooves being under the blade surface at all times.

(Fig. 27) Present 567 Connecting Rod Bearing

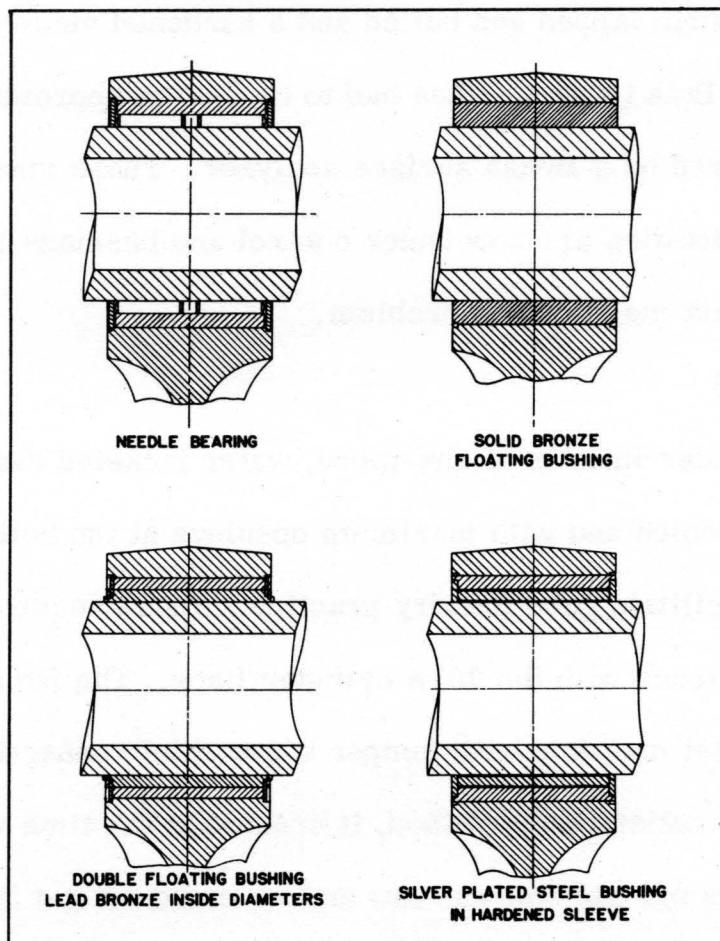
(Fig. 28)

plain bearing variations was made to run with any success until along about 1940 when somebody who did not know that bronze bearings would not work tried them again in a 567 engine. When this attempt was made the person used two cycle brains instead of four cycle. He simply made the bushing so that it would not be pressed in the rod, but would float in the rod and he gave the bushing a great deal of clearance on both the inside diameter and the outside diameter. This is possible because there is no piston pin reversal in a 2 cycle engine. I am sure that any of the designs originally tried would have worked had they been fitted with 2 cycle rather than 4 cycle clearances. These so-called floating bushings worked with a degree of success. Several designs were used in production as better interpretation of engine needs was made (Fig. 28).

The first was a solid bronze floating bushing with cross grooves, the bushing having approximately one-half inch wall thickness. The second was of two piece construction, the outer piece being steel backed with lead-bronze lining on the inside diameter. The inner piece being of similar construction, the whole assembly was locked into the eye of the rod by means of snap rings. The second design worked quite satisfactorily except for excessive wear on the outside of the soft steel inner bearing and fretting in the eye of the connecting rod.

The final design, which is the current design, is a thin walled, floating bushing of silver plated steel with very close cross grooves. The bushing floats between the hardened pin and a hardened steel sleeve pressed in the connecting rod. This design has proven for the most part quite satisfactory. It is, however, extremely sensitive to finish of the two hardened surfaces and to additive and base stocks of some lubricating oils. It was found the hard way that the piston pin finish had to be ground, lapped and buffed and a hardened sleeve finish had to be ground and honed. Both these finishes had to be held to approximately two micro-inches when measured on a Brush surface analyzer. These manufacturing defects and lubrication difficulties are now under control and bushings in railroad service present no significant maintenance problem.

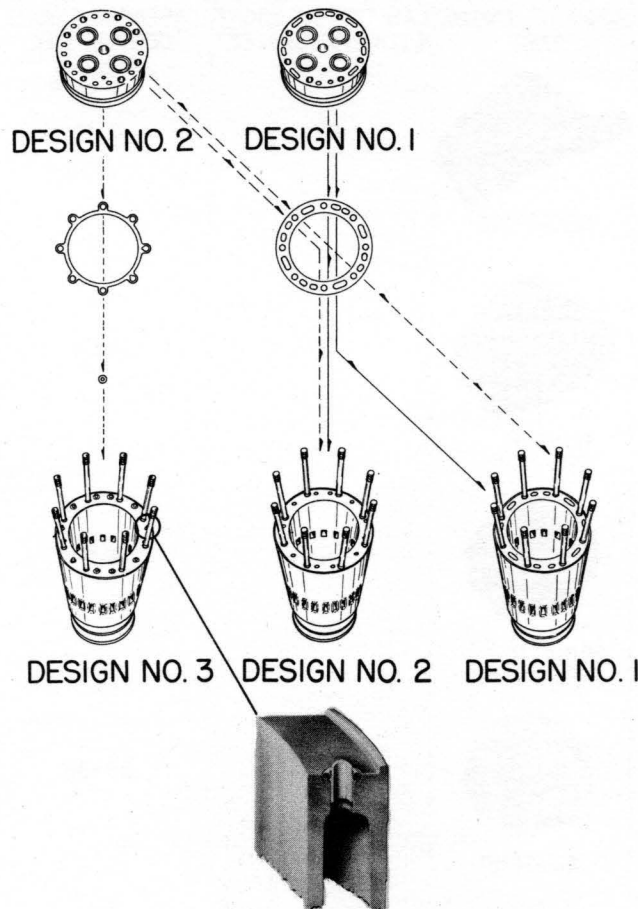
Along with the liner seal development, that is, after first reports became available on the Buna N rubber seals, it became apparent that our cylinder liner to head gasket was not satisfactory. The cylinder head gasket was a conventional copper-asbestos type.

(Fig. 30) Cylinder Head to Liner Seal

As illustrated in Figure 30, it can be seen that the non-interchangeability features did not cause the railroads to scrap any existing material, but rather to supplement the material through the normal wearout of pieces. This design consisted of a ferrule and grommet water connection using silicone rubber grommets. The combustion was sealed by means of a copper shim nominally twelve thousandths thick. This shim surrounded each stud so that a solid metal-to-metal joint could be made between the head and liner with no retightening necessary during normal maintenance.

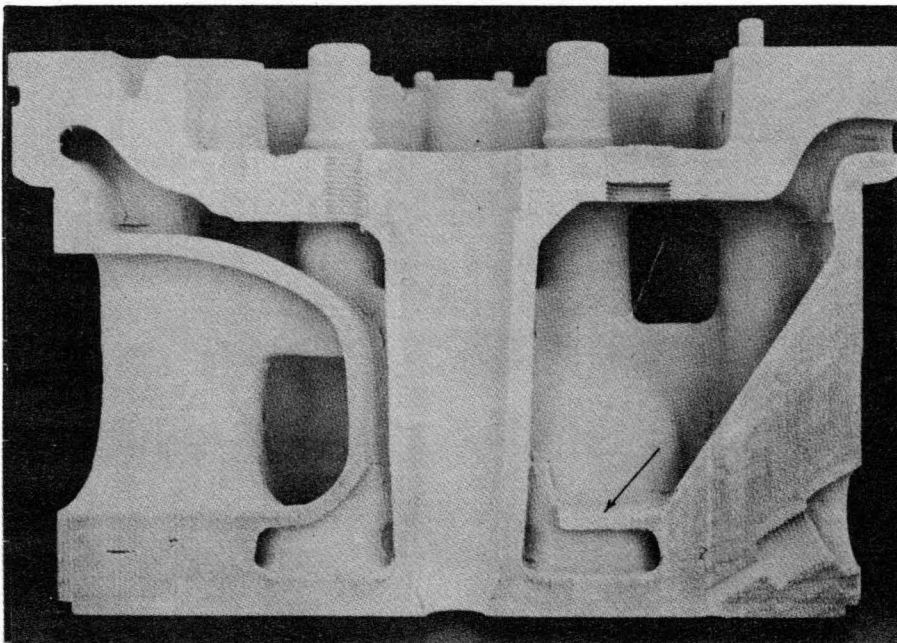
Our past experience with the 201A showed us it was necessary to make a compact, rigid, well cooled cylinder head. The 567 head design, therefore, was of the round pot type to give the maximum mechanical stiffness because of its depth diameter ratio.

(Fig. 32) Section Present Model 567 Cylinder Head

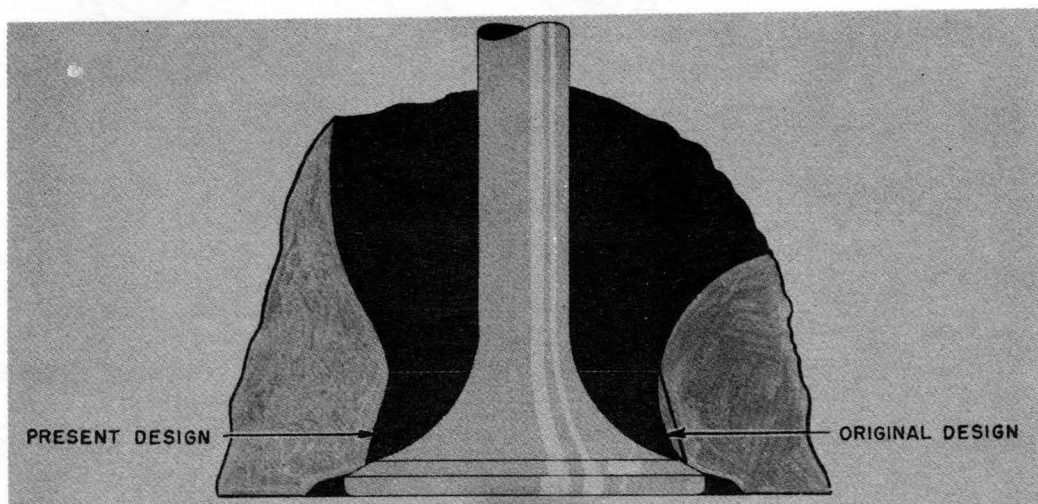
There are some things in designing an engine which you know for sure which do not turn out to be so. One of these was on the 567 cylinder head. A terrific amount of laboratory work was done to make models for air flow tests in order that we get the maximum efficiency of the exhaust gas flow through the cylinder head. As the gas left the valve seat it passed through a well rounded throat and in through the exhaust passage of the cylinder head. The air flow was measured by models with relation to the actual exhaust valve throat so that the greatest efficiency was obtained. In actual service at a later date we found that carbon deposits built up in this well rounded area, holding the exhaust valve off the seat (Fig. 33).

(Fig. 33) Valve Throat Design

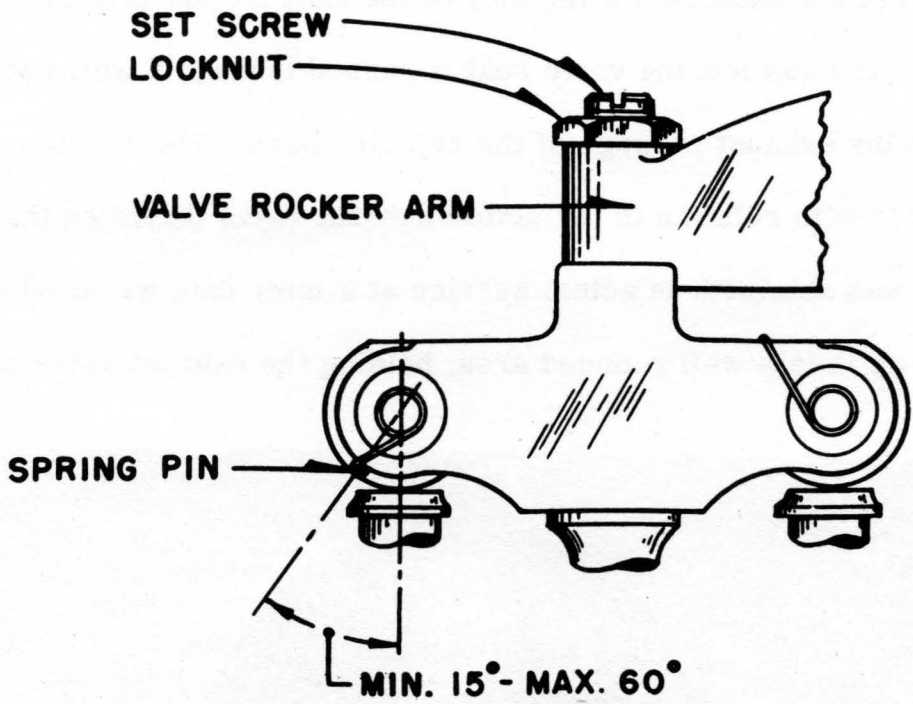
(Fig. 34) Mechanical Valve Lash Adjuster

As you no doubt know, the mechanical cam lash adjuster depends on the friction between the valve stem end or, as in this case, the valve stem cap and the cam itself, the cam being spring loaded in order to maintain zero lash. It was found that the variation in the lubricity or slipperiness of lubricating oils radically changed this frictional characteristic. When the cam of the lash adjuster would rotate due to lack of friction, the exhaust valves would be opened later in the cycle
