**HISTORY AND DEVELOPMENT  
OF THE 567 SERIES GENERAL  
MOTORS LOCOMOTIVE ENGINE**

***Paper by E. W. Kettering  
Chief Engineer  
Electro-Motive Division  
General Motors Corporation***

***Presented before  
American Society of Mechanical Engineers  
Atlantic City, New Jersey  
November 29, 1951***

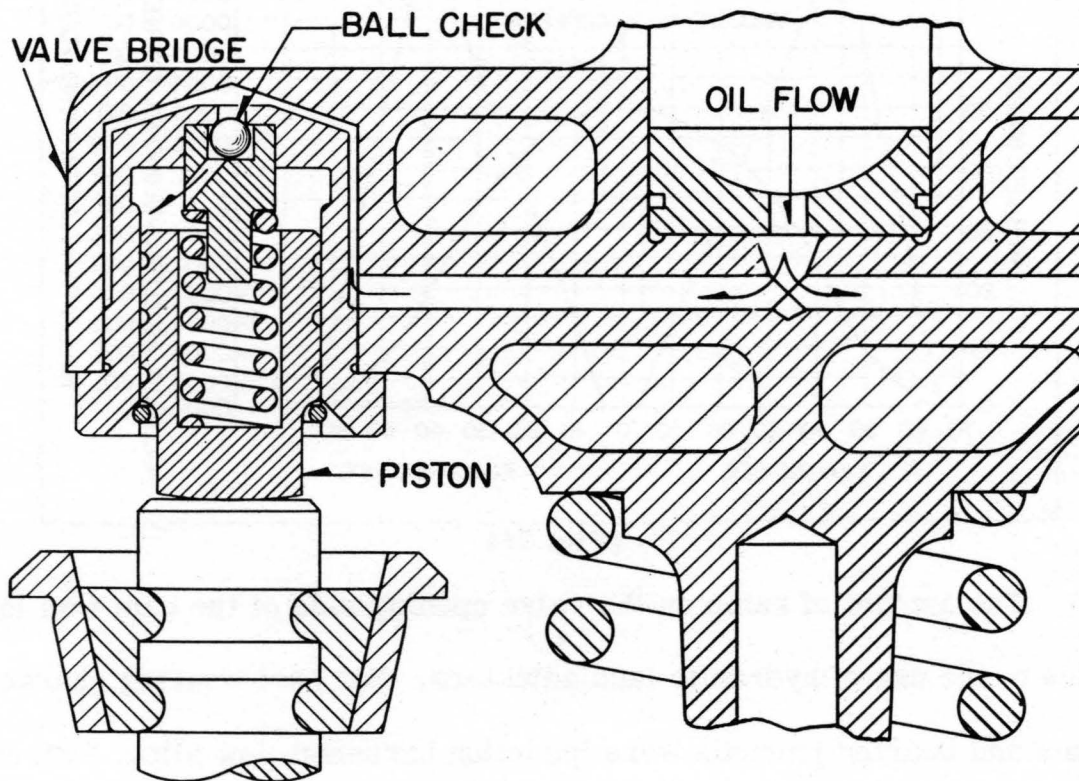
and closed earlier in the cycle. Inasmuch as the camshaft was designed with a slow opening and slow closing ramp, this malfunctioning of the lash would allow the valve to close at high velocity which induced excessive stresses in the exhaust valve, causing fatigue failure. Since it was rather impractical to design a cam for every frictional characteristic, the valve gear was modified in 1940 to hydraulic lash adjusters of our own design (Fig. 35).

(Fig. 35) Model 567 Hydraulic Valve Lash Adjuster

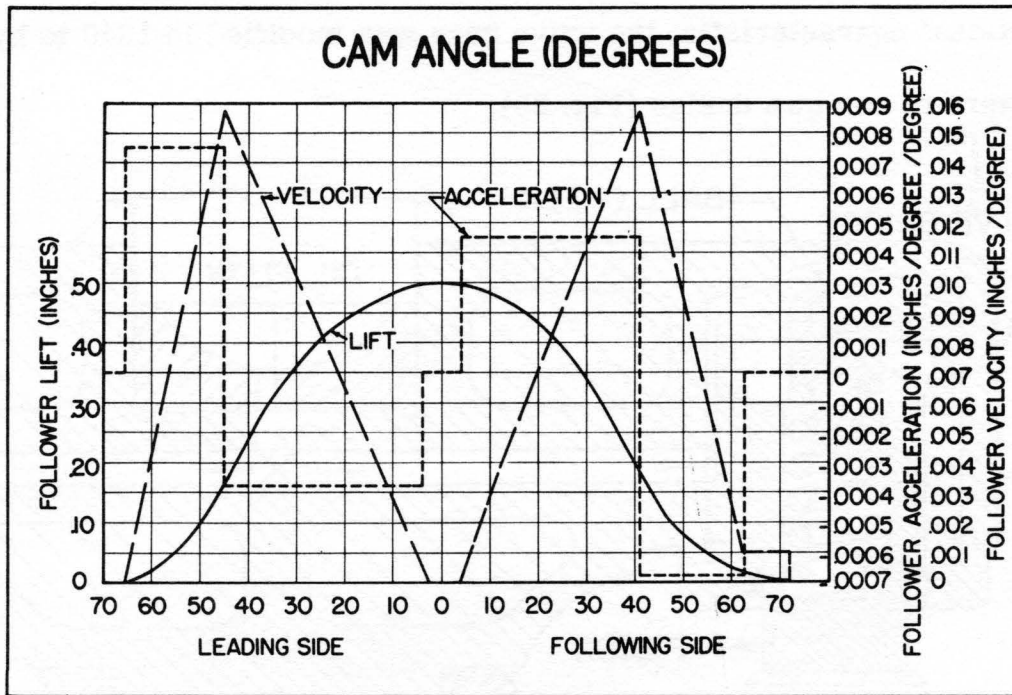
(Fig. 36)

6° earlier and closing 2° later. (See Fig. 36). The modification of the intake port timing from 50° before bottom center and 50° after bottom center to 45° before and 45° after, plus the camshaft change, gave us a decrease in specific fuel consumption at rated power of approximately 7%.

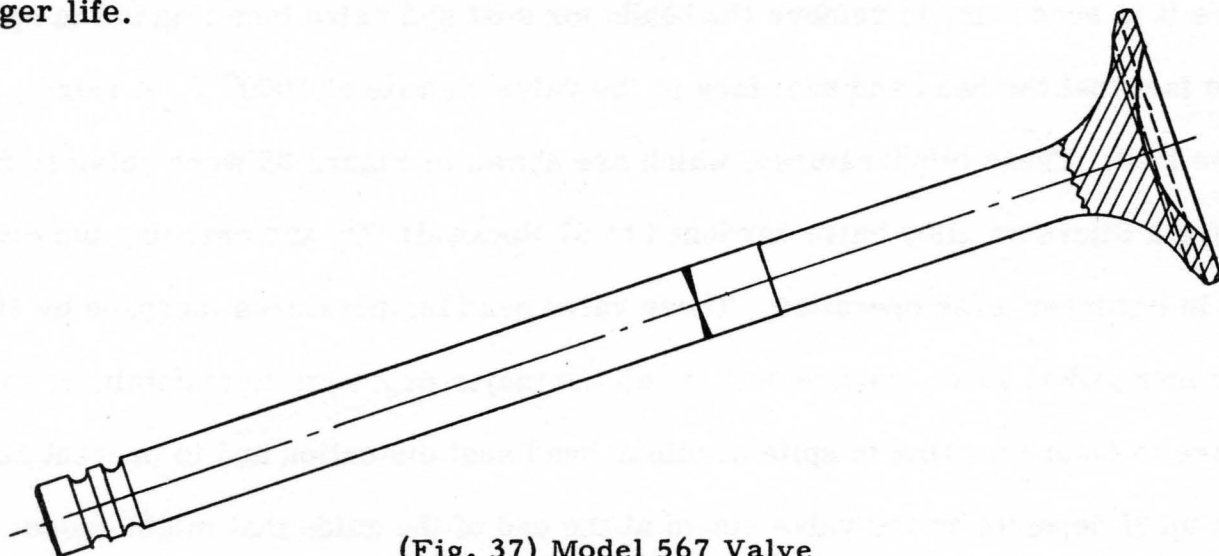
(Fig. 37) Model 567 Valve

The valve head (Fig. 37) was cupped for a more uniform section from the stem out to the face to give some flexibility for seating with minor head seat distortion. The early history of this valve showed more rim failures than we desired. As a result, the hard facing was removed since it was possible that defects at the fusion zone or stresses due to the difference in stiffness of the Stellite and base metal could have contributed to these failures. However, the major reduction in this type failure was effected by the change from mechanical lash adjusters to hydraulic lash adjusters.

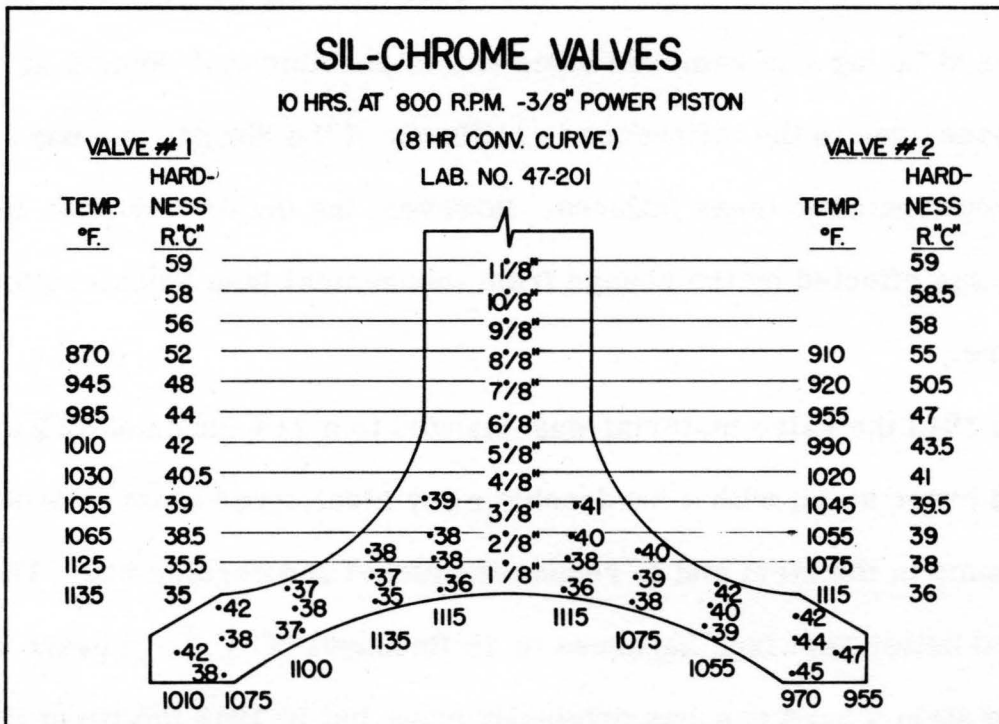
(Fig. 38)

Normally in freight and passenger service the valve will run two years before it is necessary to remove the heads for seat and valve face regrind in spite of the fact that the head and seat face of the valve operate at 1000° F. at rated engine load. These temperatures, which are shown in Figure 38 were obtained by running a Silchrome alloy valve hardened to 57 Rockwell "C" and checking the draw-back in hardness after operation. These valve head temperatures increase by 100° F. or more when valve leakage occurs, so the major problems in maintaining valve life are to insure seating in spite of minor head seat distortion and to prevent heavy build-up of deposits on the valve stem at the end of the guide that might cause sticking valves. The elimination of valve stem sticking can be adequately accomplished by the use of additives, that is, Heavy Duty lubricating oils.

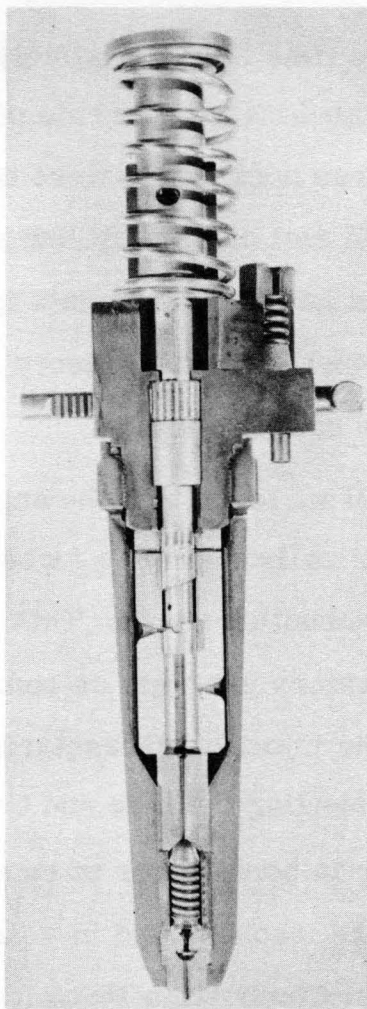
(Fig. 39) Model 567 Injector

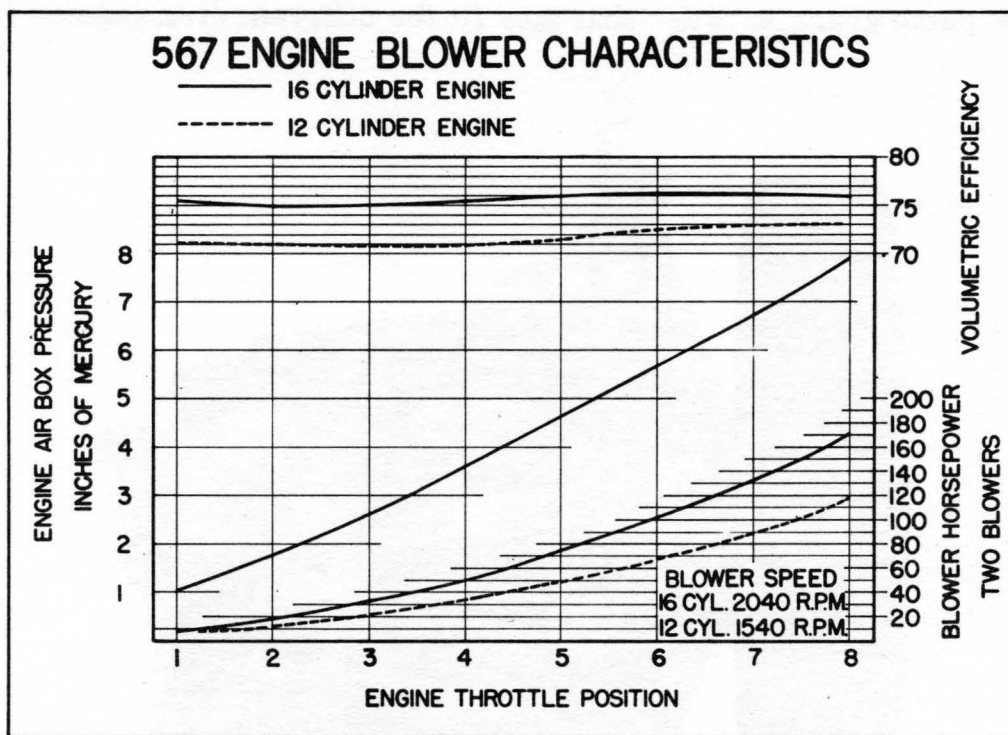
(Fig. 40)

direct reflection of savings to the customer. Figure 40 shows the characteristics of the 567 engine blower.

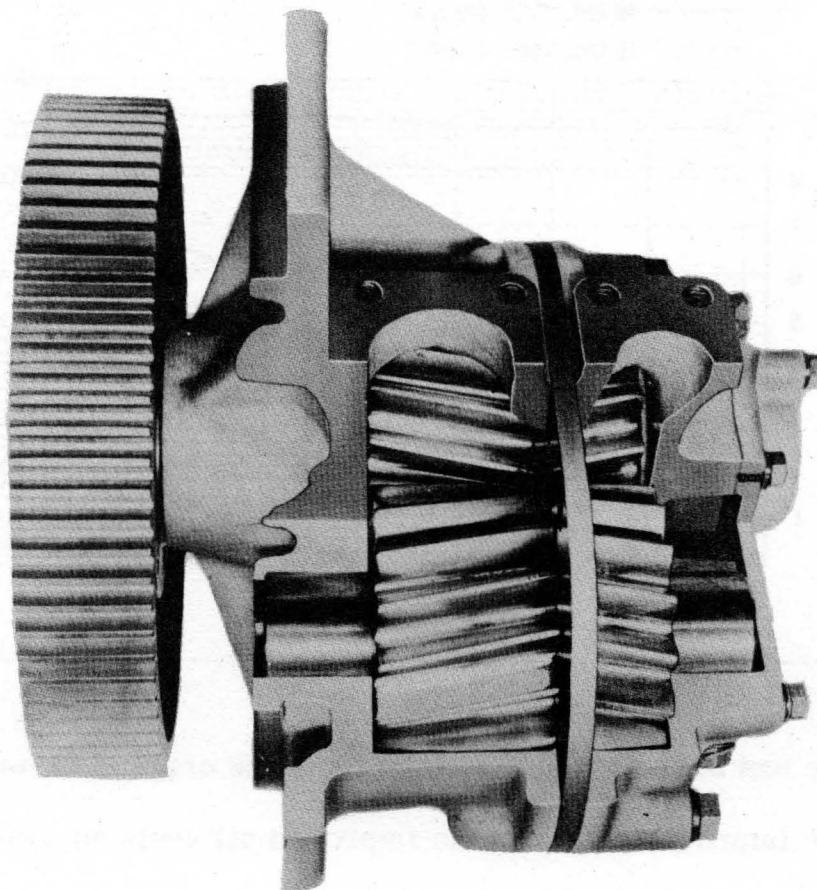
oil pumps on the complete engine line were made with interchangeable drive gears and the same size pump gears and bores, varying the length of the housings and the length of the pump gears in order that they fit the different size engines (Fig. 41).

(Fig. 41) Typical Model 567 Oil Pump

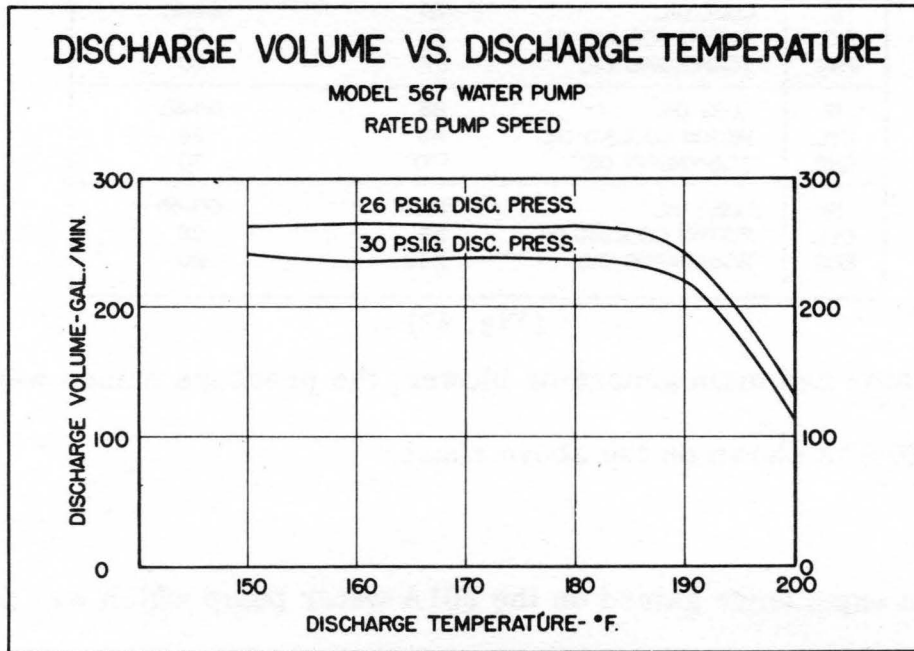
(Fig. 43)

The current 567 pump is quite satisfactory from the standpoint of water pumping characteristics as shown in Figure 43, but is still somewhat inadequate in its seal life. Redesigns have been made which show a definite improvement in pump seal life and pump cost.

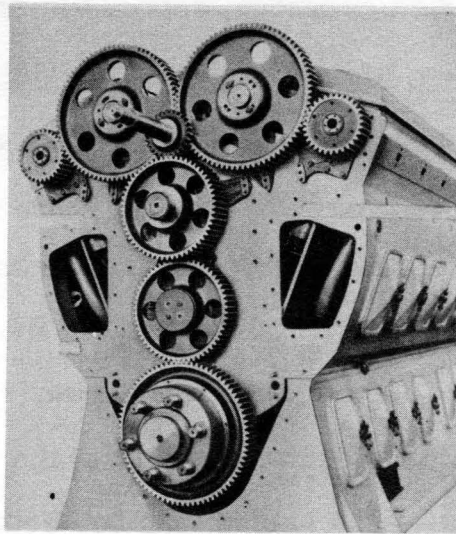
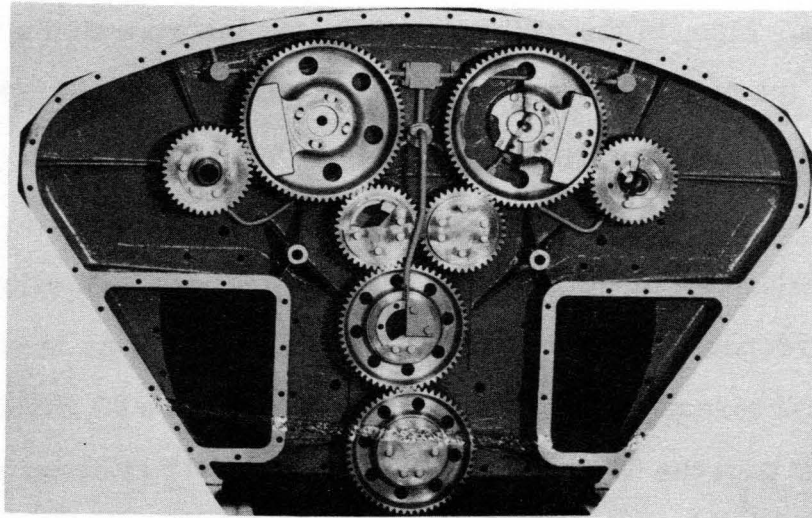
In 1941 a complete redesign of the gear train was made and incorporated in what became known as the 567A engine. A comparison of these two designs can be seen in Figure 44.

**Current 567 Design**

**(Fig. 44) Original 567 Design**

On the basis of our calculations, relative improvement of gear tooth wear for the new gear train vs. the old gear train was 2.8 to 1. This is based on Buckingham's wear factor formula. In actual service the new design has shown about a 4 to 1 improvement, that is, 8 years vs. 2 years on the 16 cylinder engine. This 4 to 1 improvement is no doubt due to the increased area as well as better lubrication of the gear bushings which, in the case of the first design, caused premature gear tooth wear due to loss of center distance.

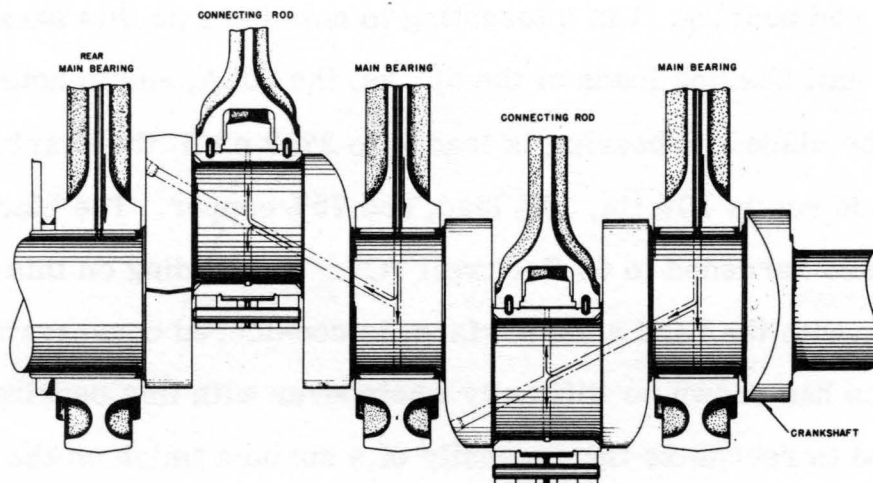
Main bearing lubrication in the 567 engine is from the top through the unloaded upper bearings instead of through the lower main bearings as in the case of the 201A. This meant that a solid lower main bearing could be used free of grooves. We felt it essential from experience not to groove the loaded half of the main bearing as this doubles the actual bearing load. See Figure 46 for lubricating oil system.

(Fig. 46) Crankshaft Bearing Lubrication

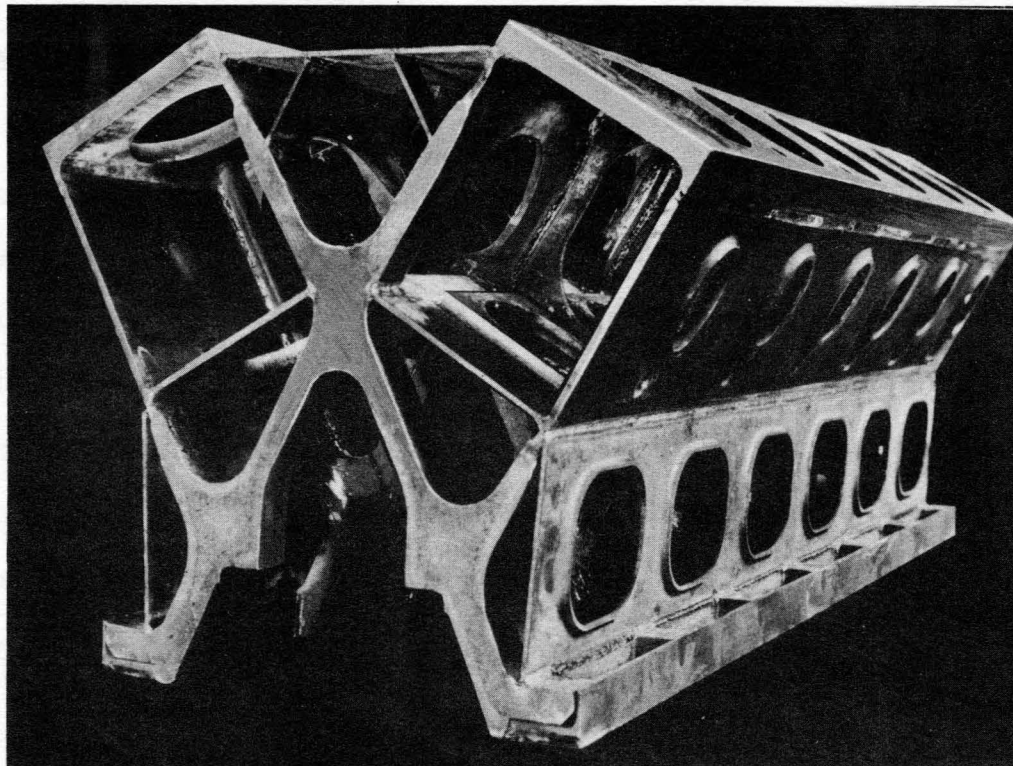
The crankcase of the 567 engine was developed to overcome the basic weaknesses of the 201A (Fig. 47).

(Fig. 47) 12-201A Fabricated Crankcase

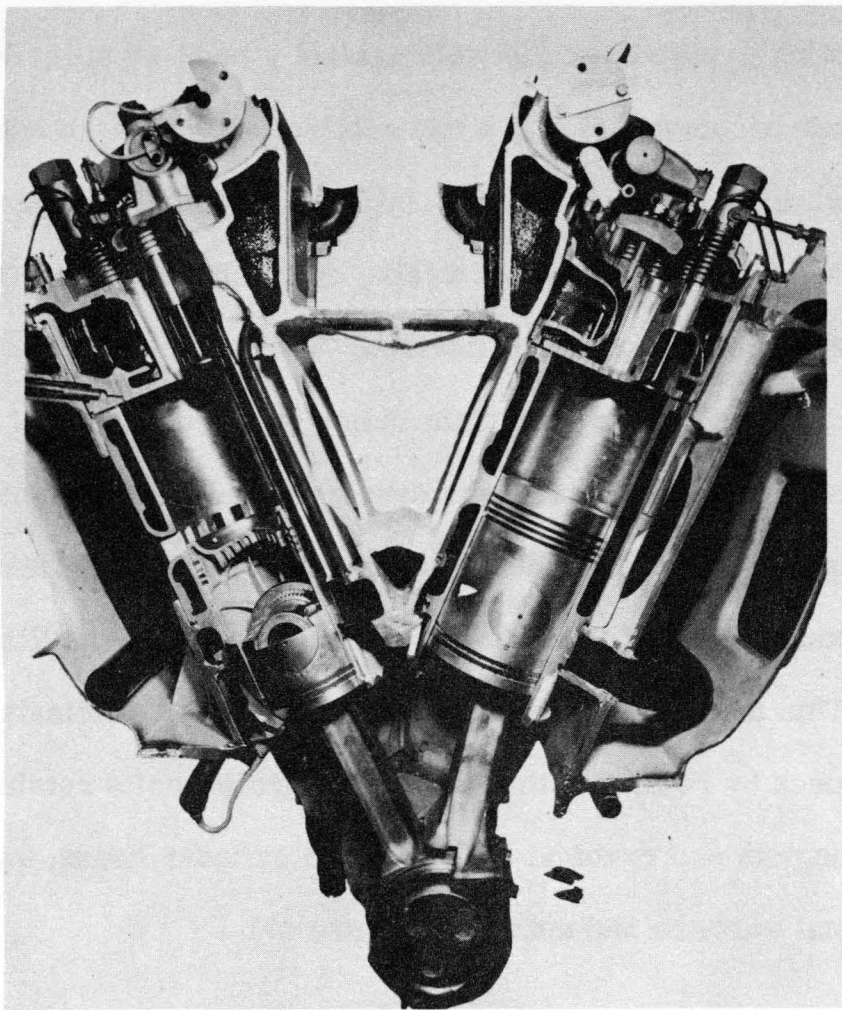
**(Fig. 48) Section-Original 567 Design**

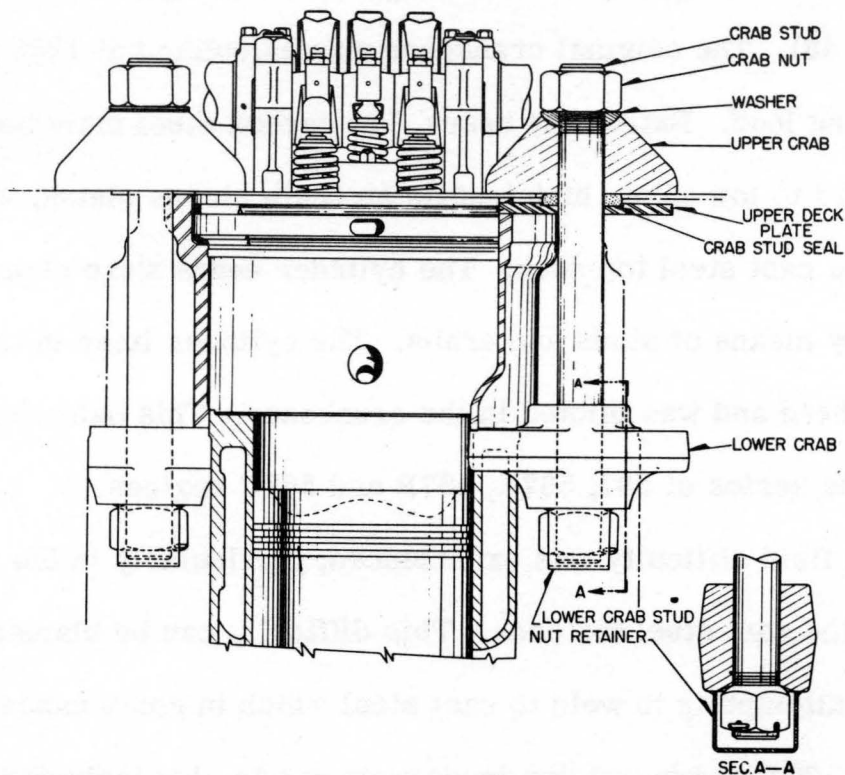
(Fig. 49) Cylinder Head Retention

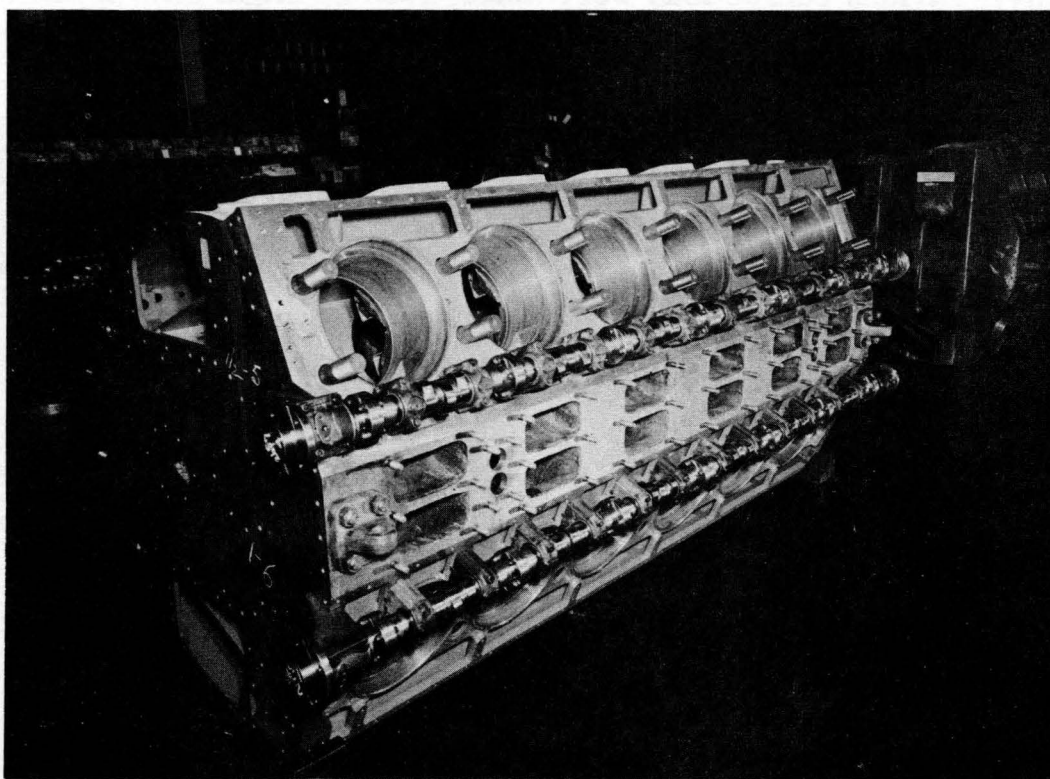
(Fig. 50) Model 567-A Crankcase

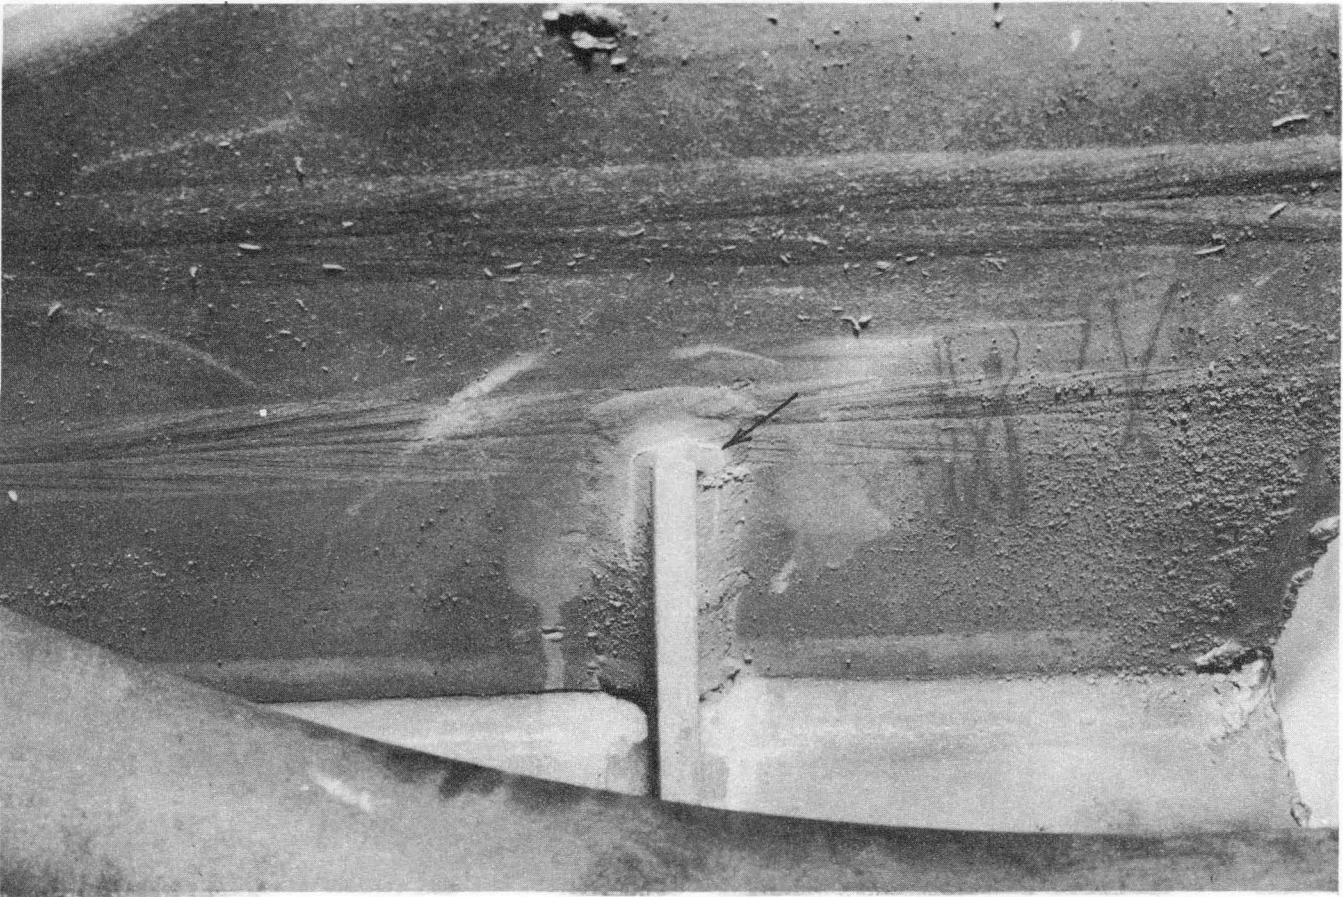
(Fig. 51) Ill. Central R.R. Crankcase 1495 Gusset Weld Failure

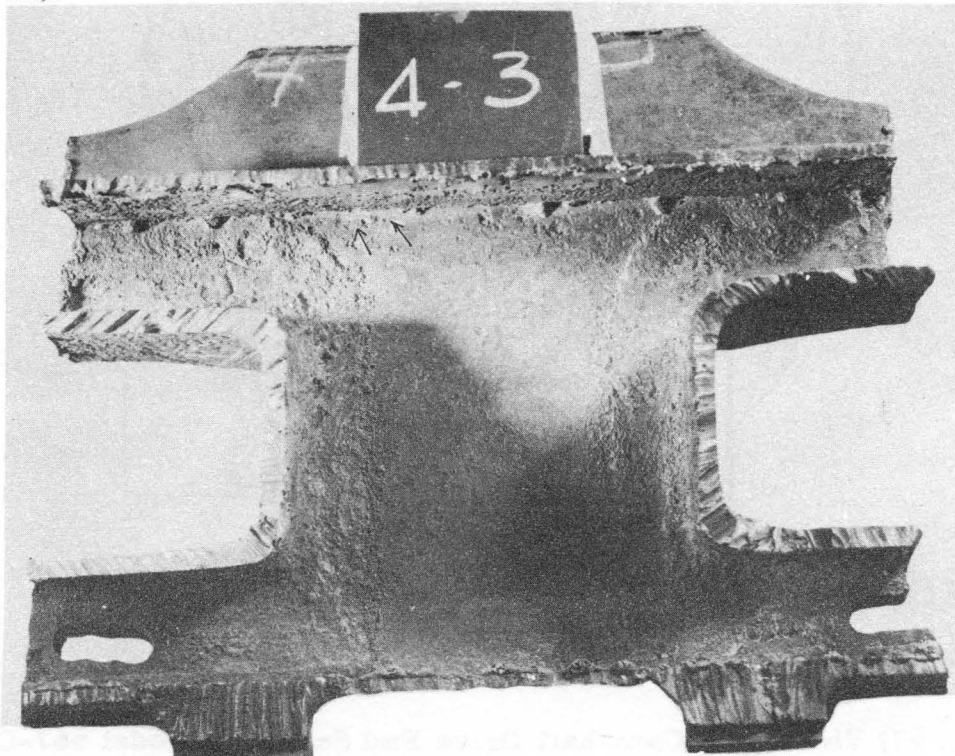
(Fig. 52) Stress Plate Cracks in Engine No. 1835, Santa Fe R.R.

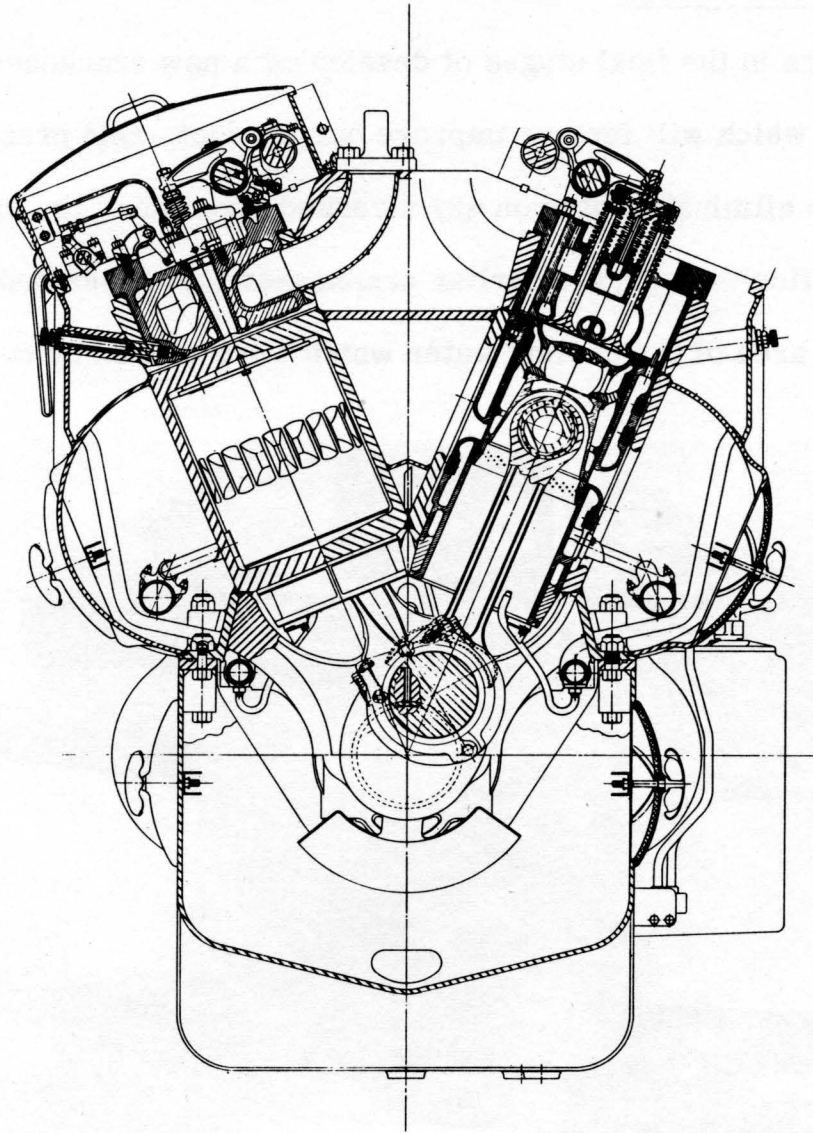
**(Fig. 53) View from Camshaft Drive End Section - Model 567-C**

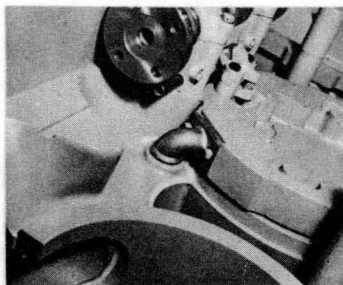
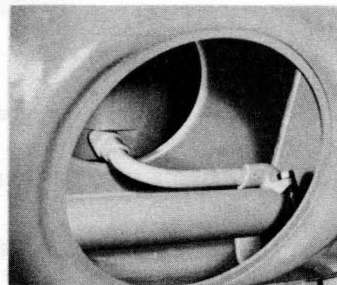
**Upper Water Jumper from Cylinder Head**

**Lower Water Jumper to Cylinder Liner**

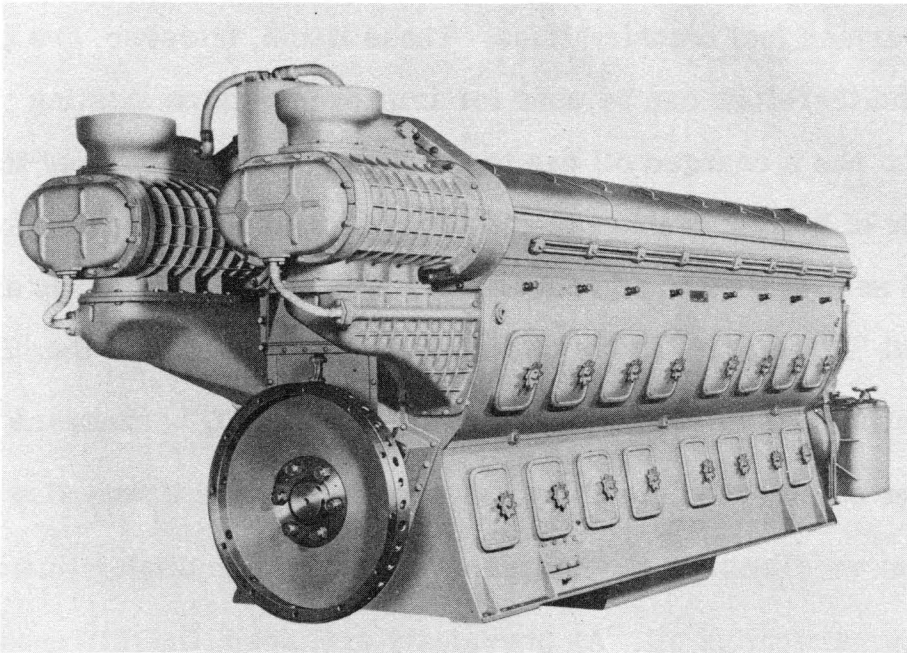
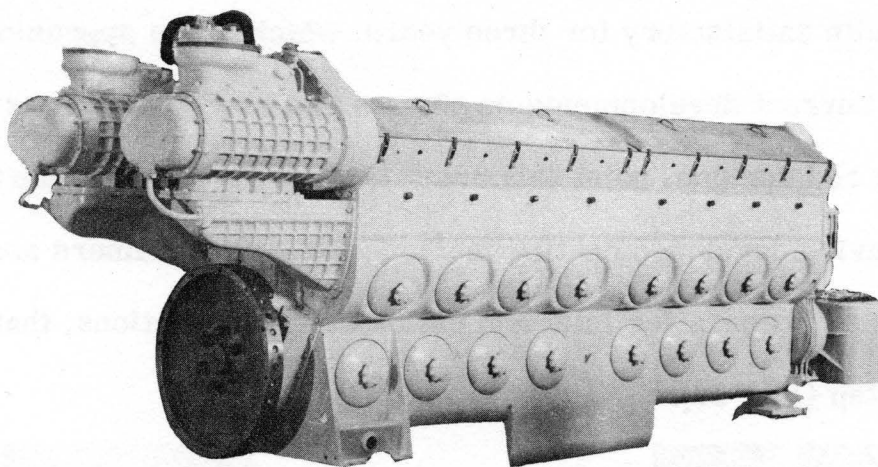
(Fig. 55) Comparison 16-567B and 16-567C Engines

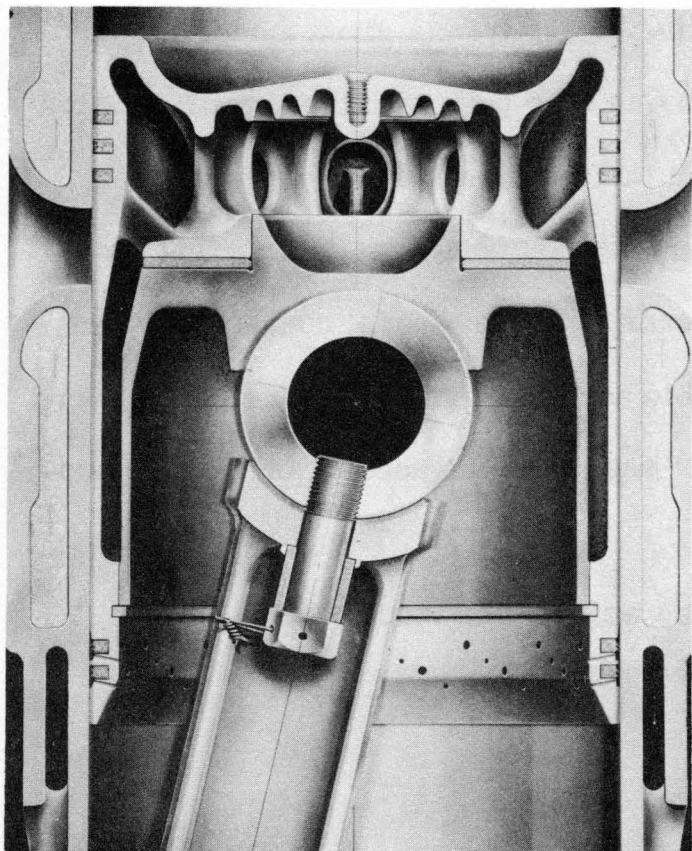
One of the developments, as mentioned in a previous paragraph (Fig. 56) is a new design piston pin carrier and wrist pin, which we choose to call the trunnion carrier and piston.

Trunnion Type Piston Pin and Carrier

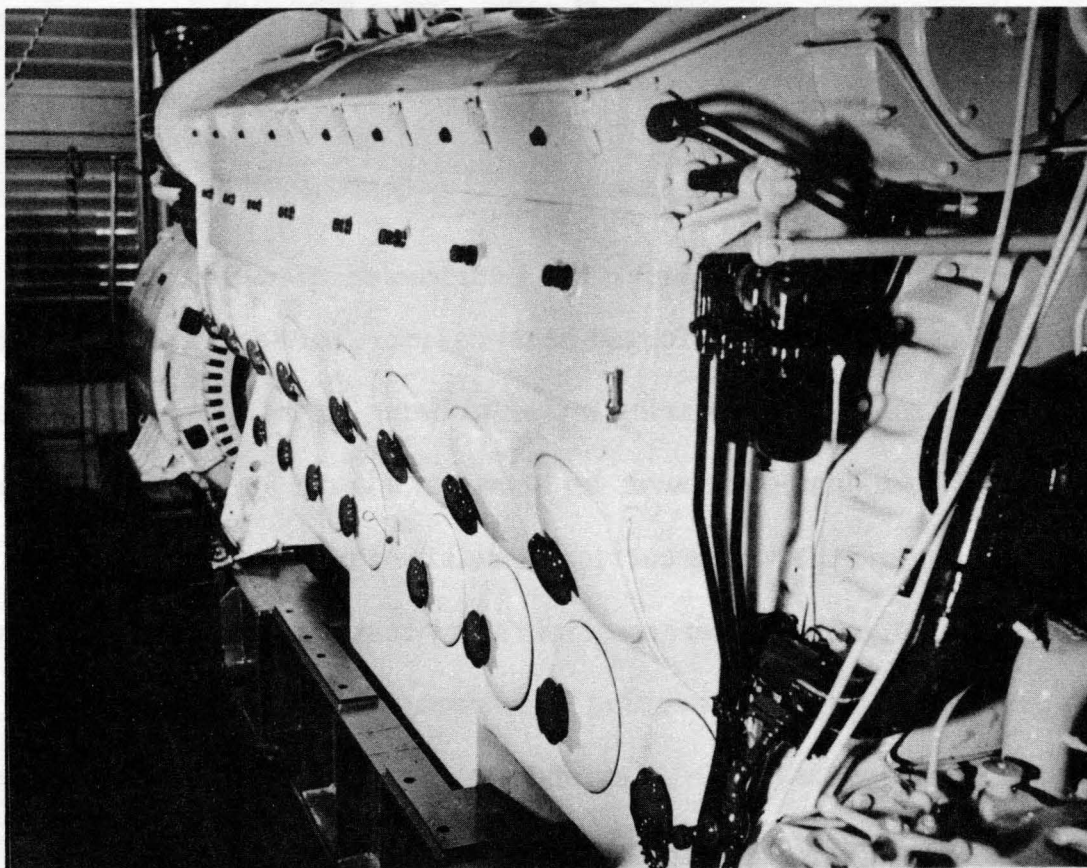
(Fig. 58) 16-567C Engine on Test

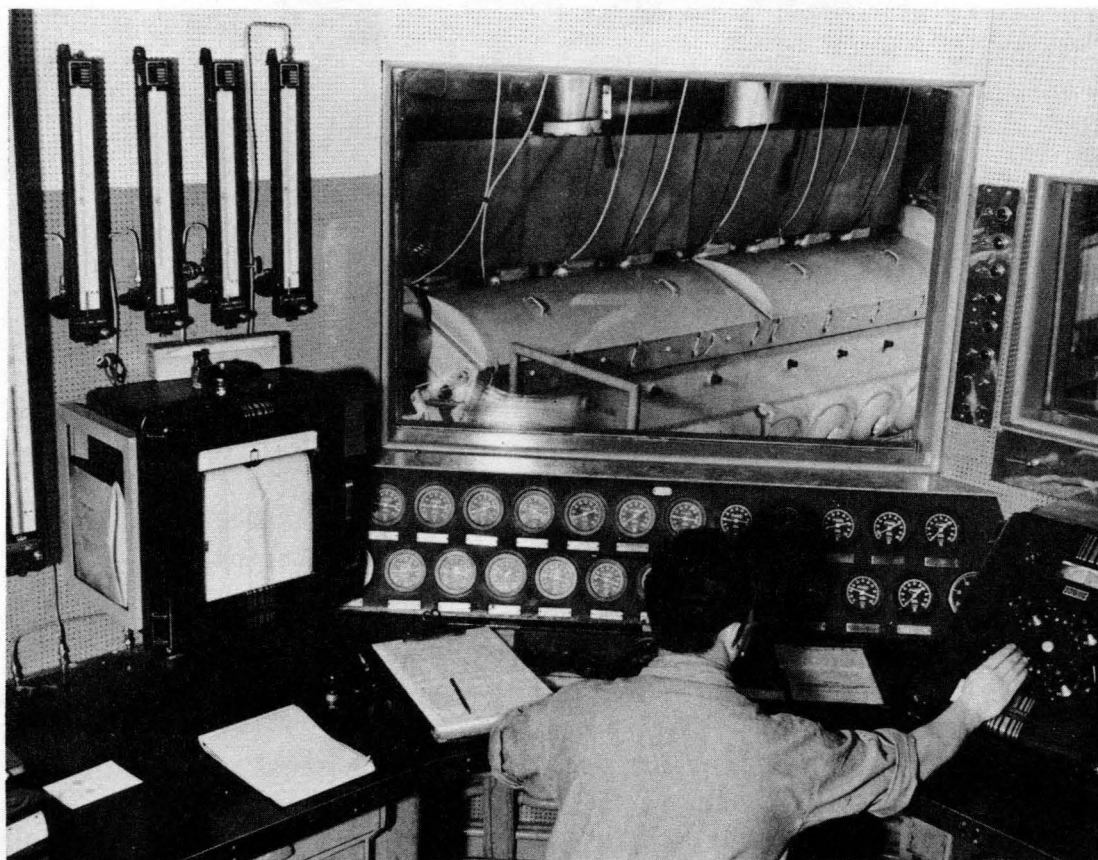
In addition to the future developments which have been mentioned throughout this paper, we are well equipped for and are going ahead with many other engine developments too numerous to list here. It might be well to show you a few pictures (Fig. 58 and 59) of one of our engine test cells and add that there are six such test cells for full scale experimental testing at Electro-Motive Division.

(Fig. 59) Experimental Test Cell Control Room

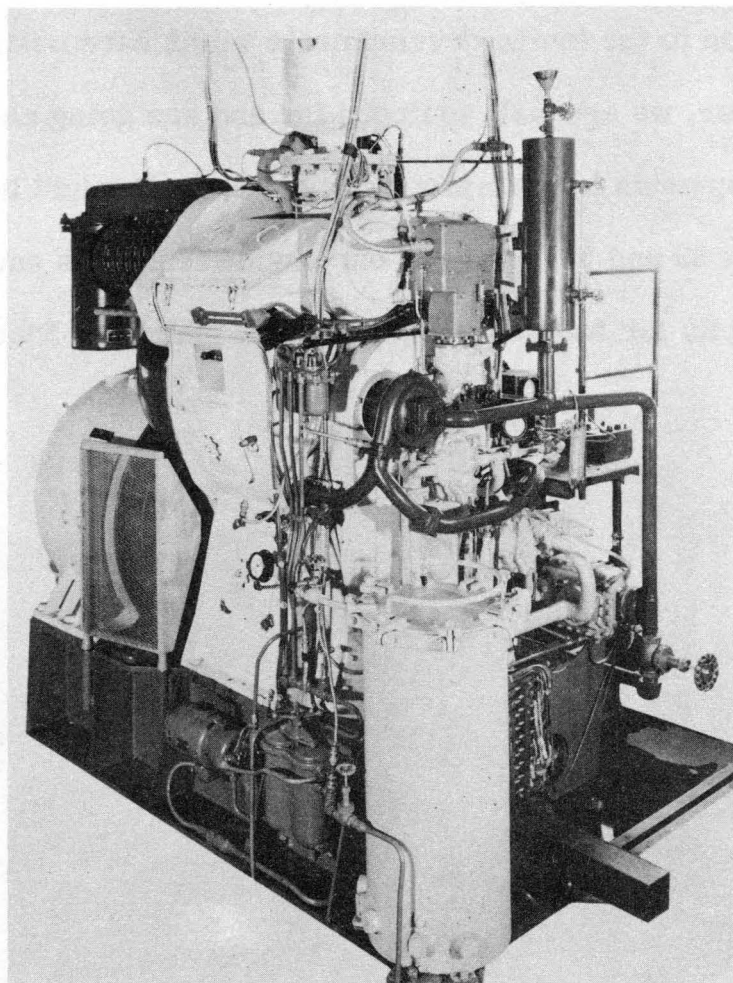
(Fig. 60) Two Cylinder 567B Test Engine

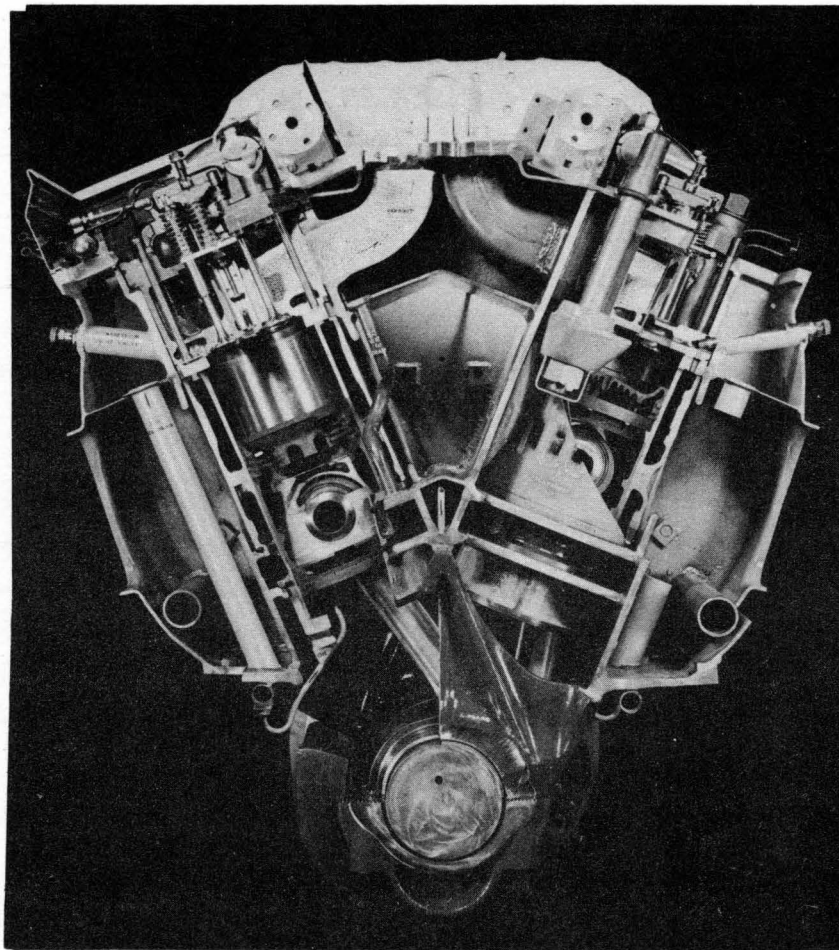
**(Fig. 61) Model 567-B Engine Cross Section**

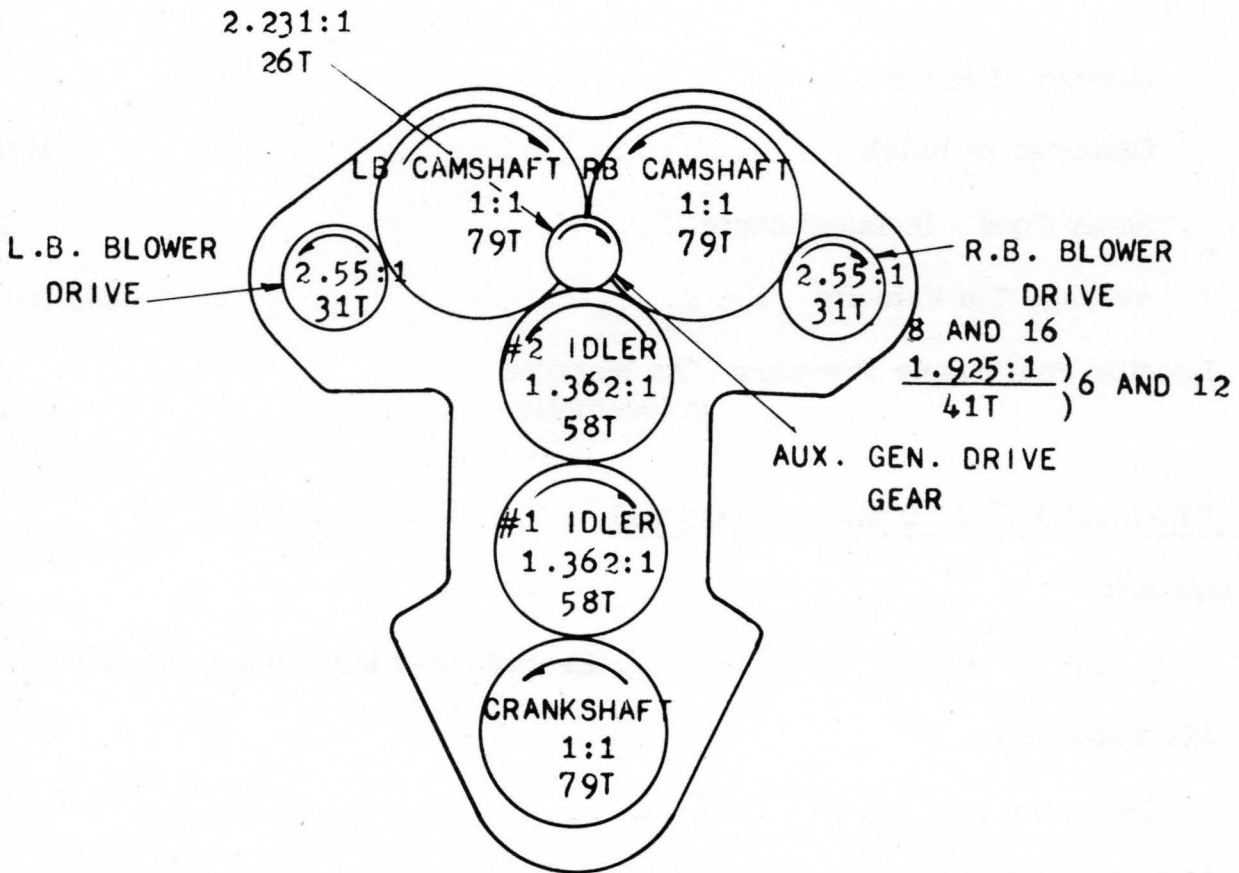
VI. CAMSHAFT AND BLOWER DRIVE GEAR TRAIN

SPEED RATIO, NUMBER OF TEETH

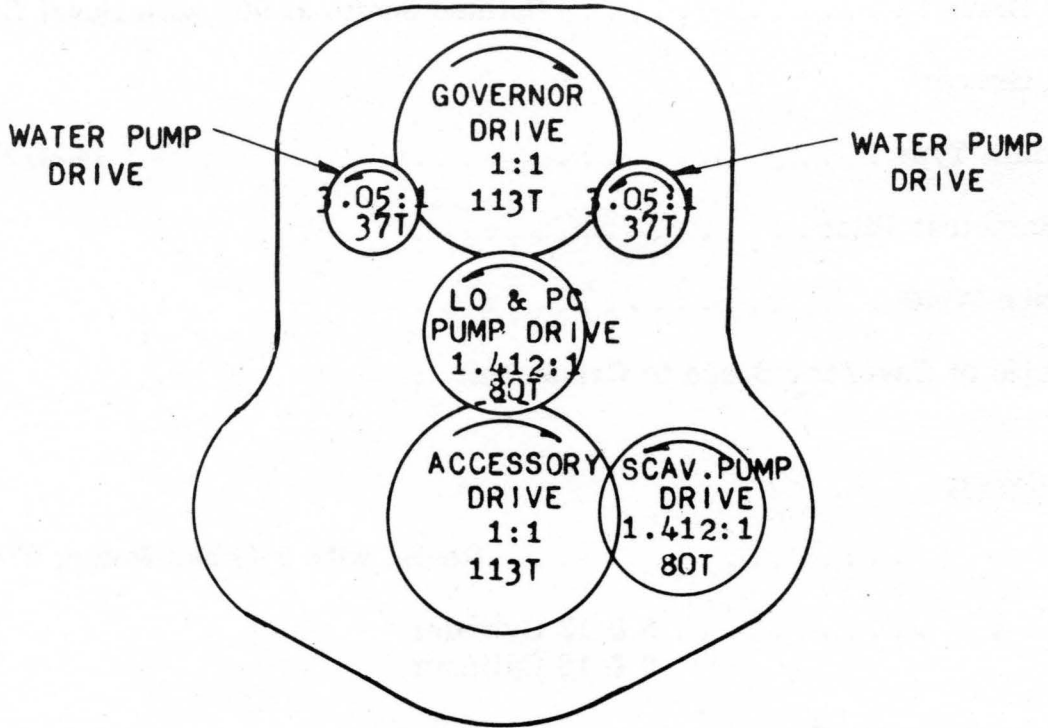
VII. ACCESSORY DRIVE GEAR TRAIN

SPEED RATIO, NUMBER OF TEETH
